## PROPERTY AND SERVICES COMMITTEE AGENDA

**PS26/024 General Cemetery Chapel Condition Survey**

### Condition Report

Inspected by:  
Daniel Elkington BArch(Hons) MArch ARB RIBA FHEA  
24<sup>th</sup> November 2023

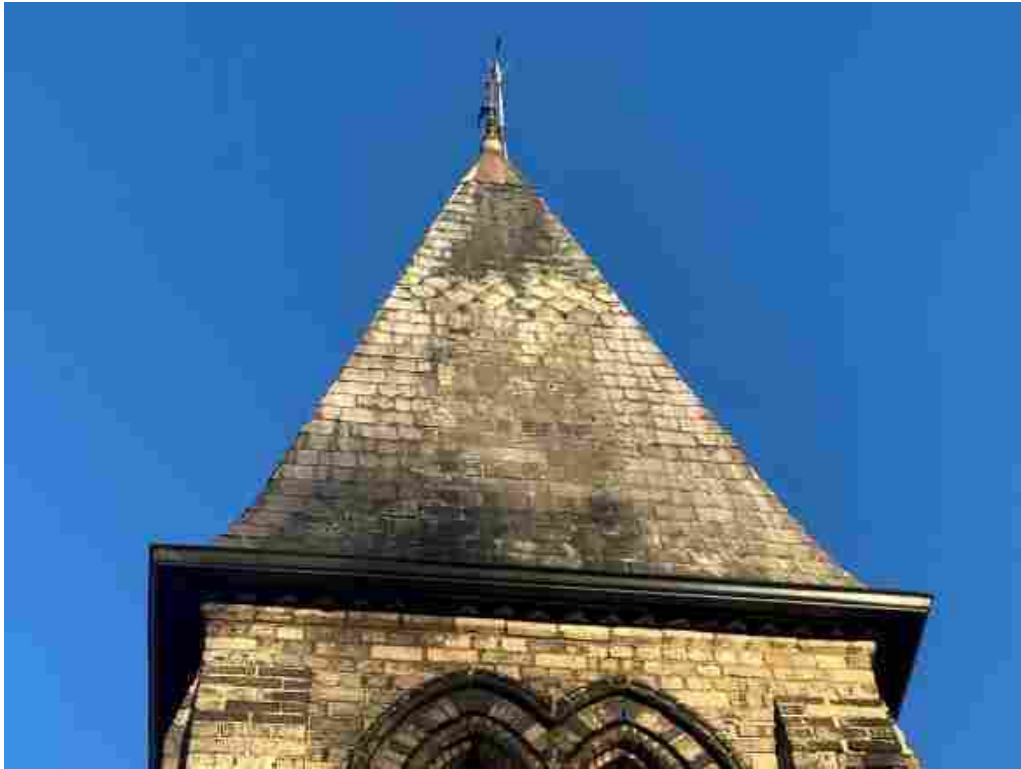
Slating appears to be in good condition, although gutters should be cleared.

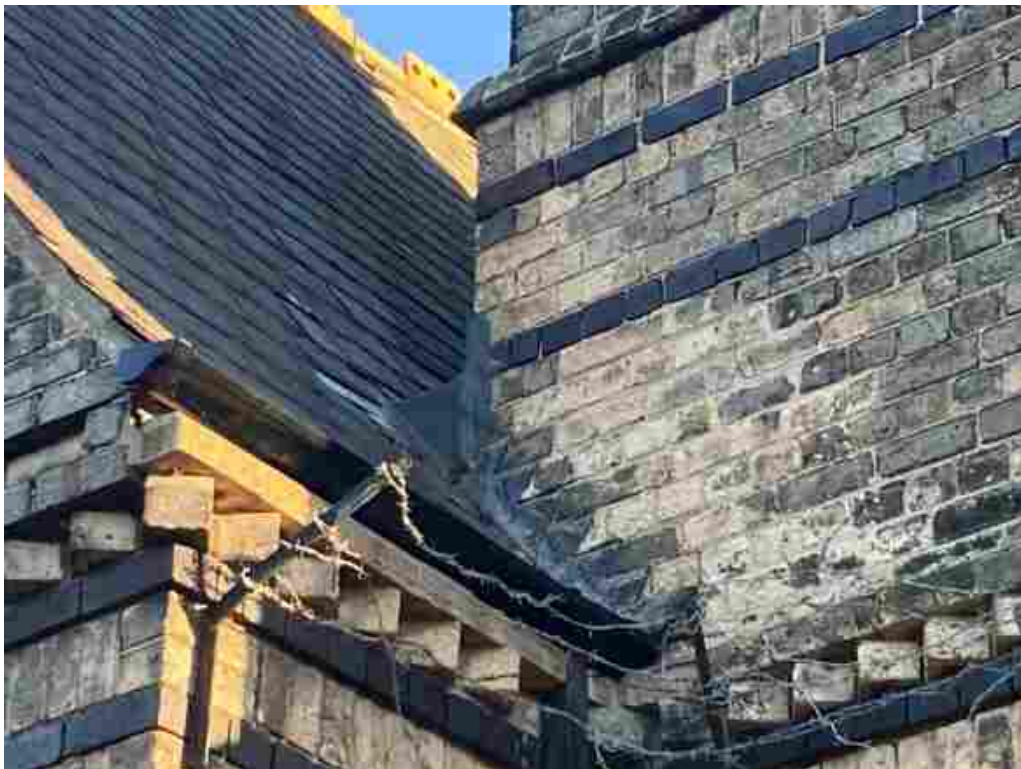
Later repairs to Tower valley.

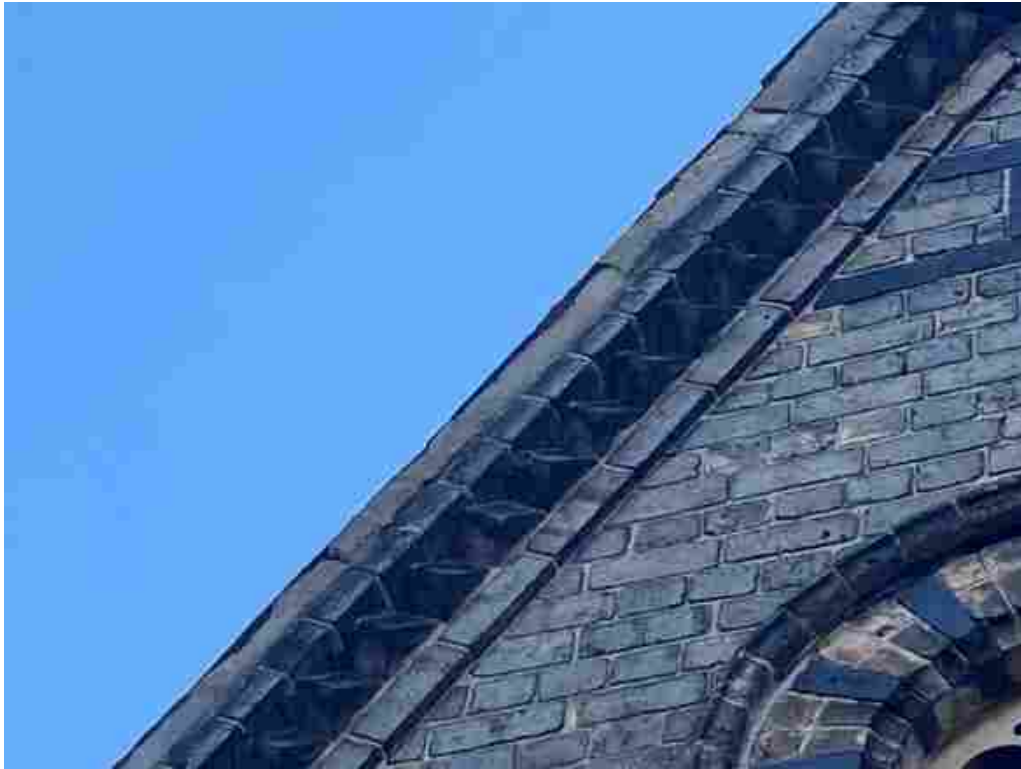
Missing verge pointing.

**D** Cracked and missing verge pointing should be removed and repointed in lime mortar. 2

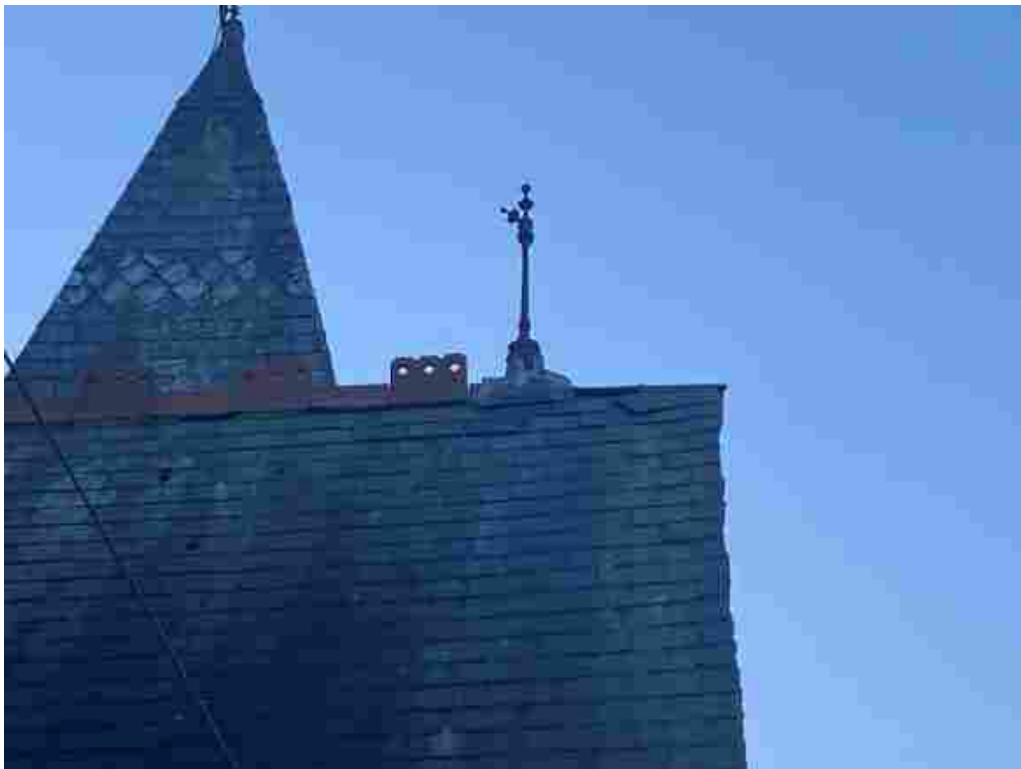
Loose slate and missing decorative ridge tiles.

**D** North Chapel – North West Slope (Behind Tower) 2  
Missing decorative ridge tiles should be replaced.

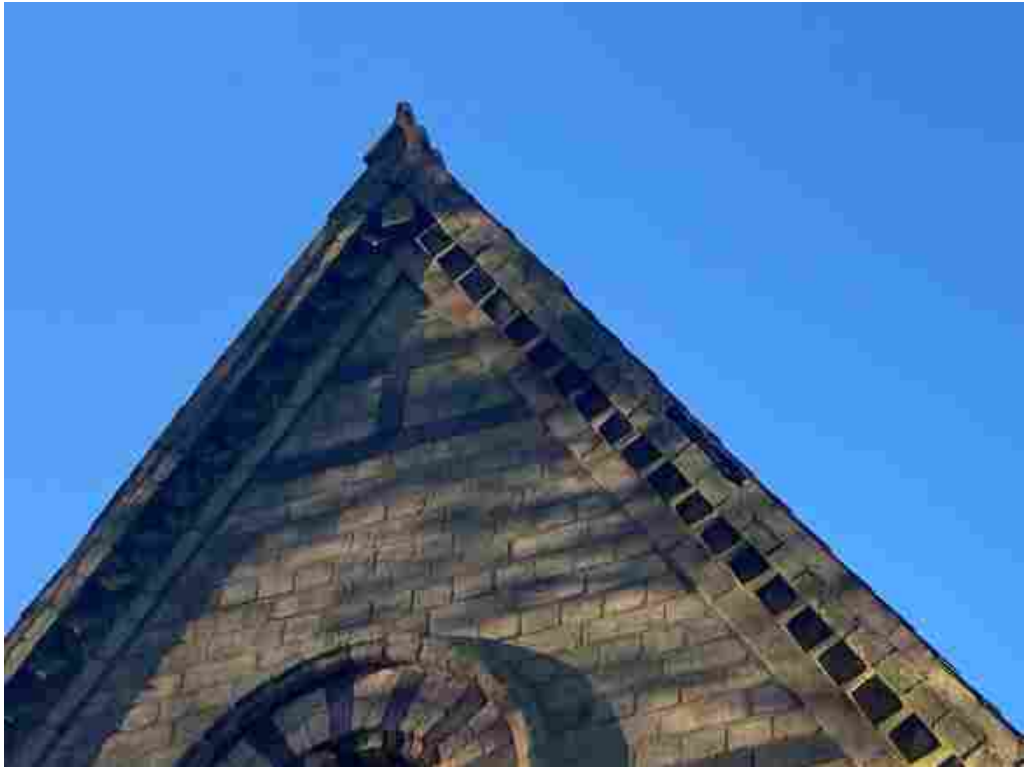
Missing or cracked verge pointing.

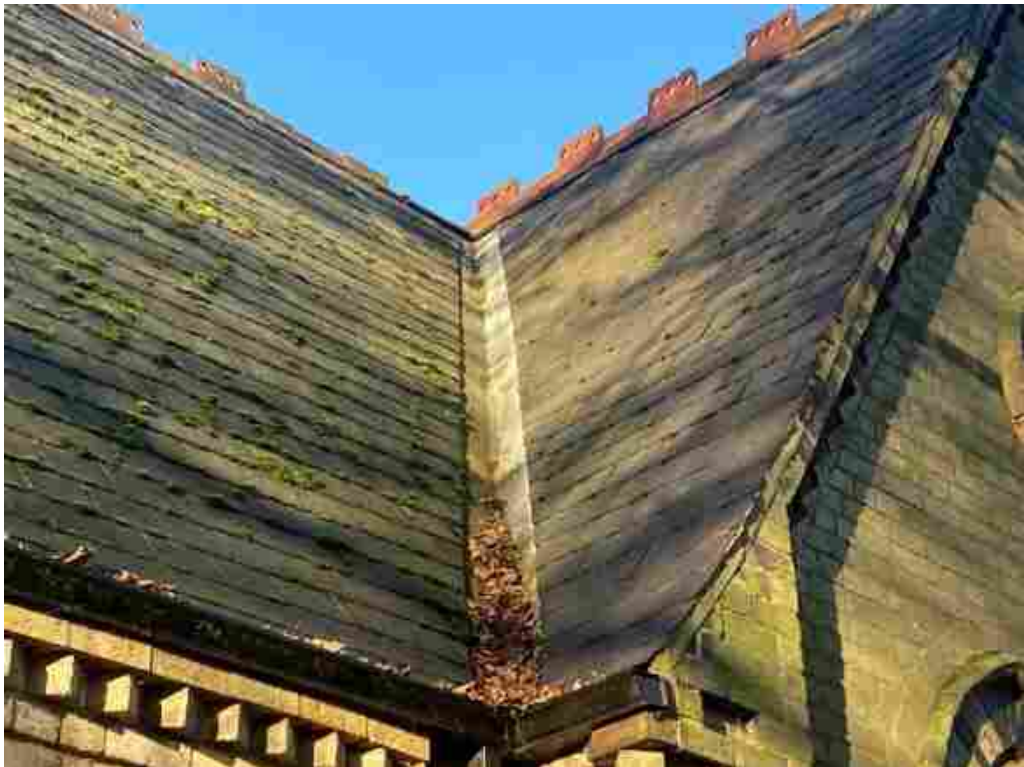
Buildup of leaves to valley.

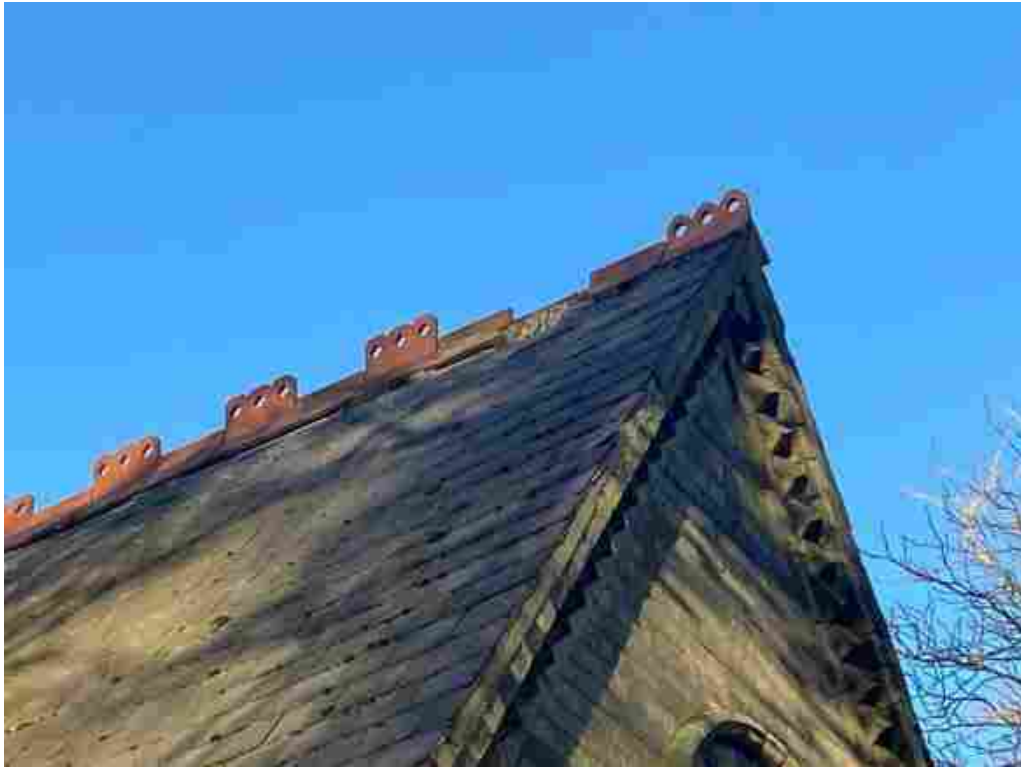
Missing decorative ridge tiles.

**D** Similarly to the previous slope, missing decorative ridge tiles should be replaced. 2

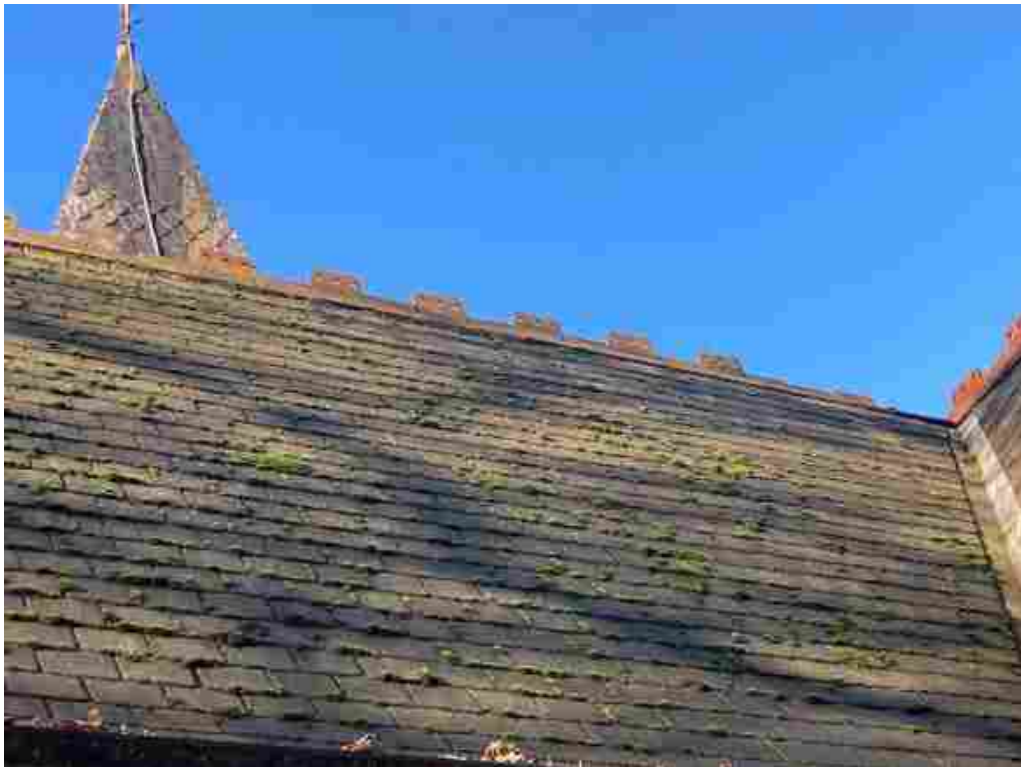
Moss buildup to Chapel should be cleared.

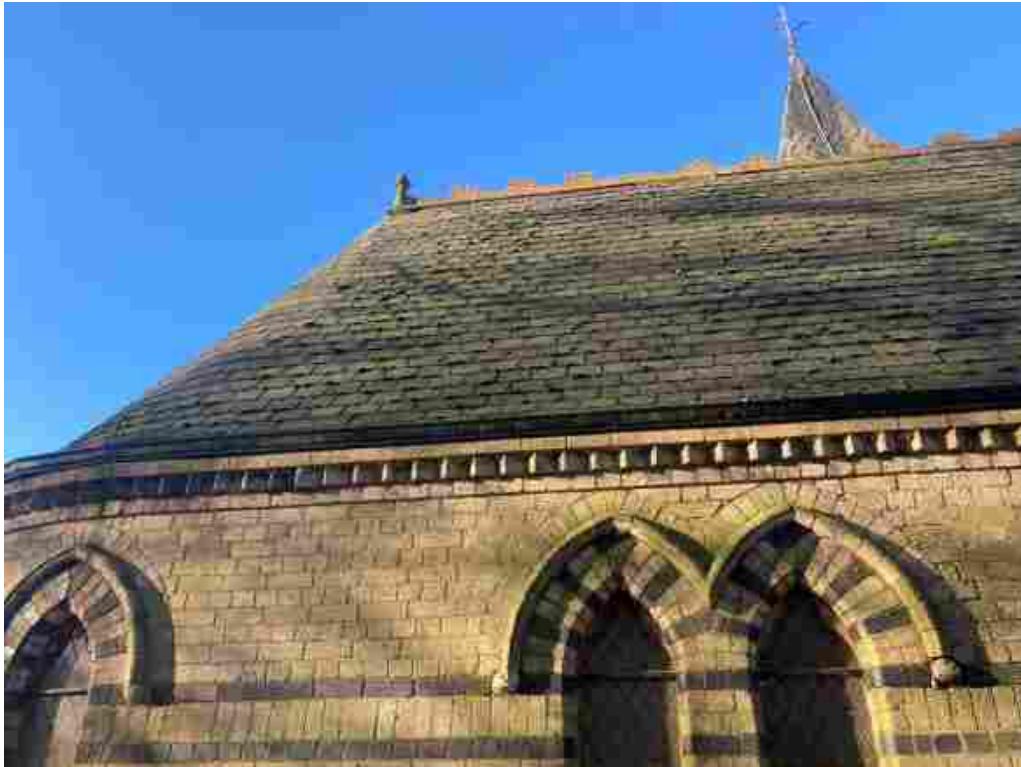
Slating generally appears in satisfactory condition, barring missing ridge tiles and pointing.

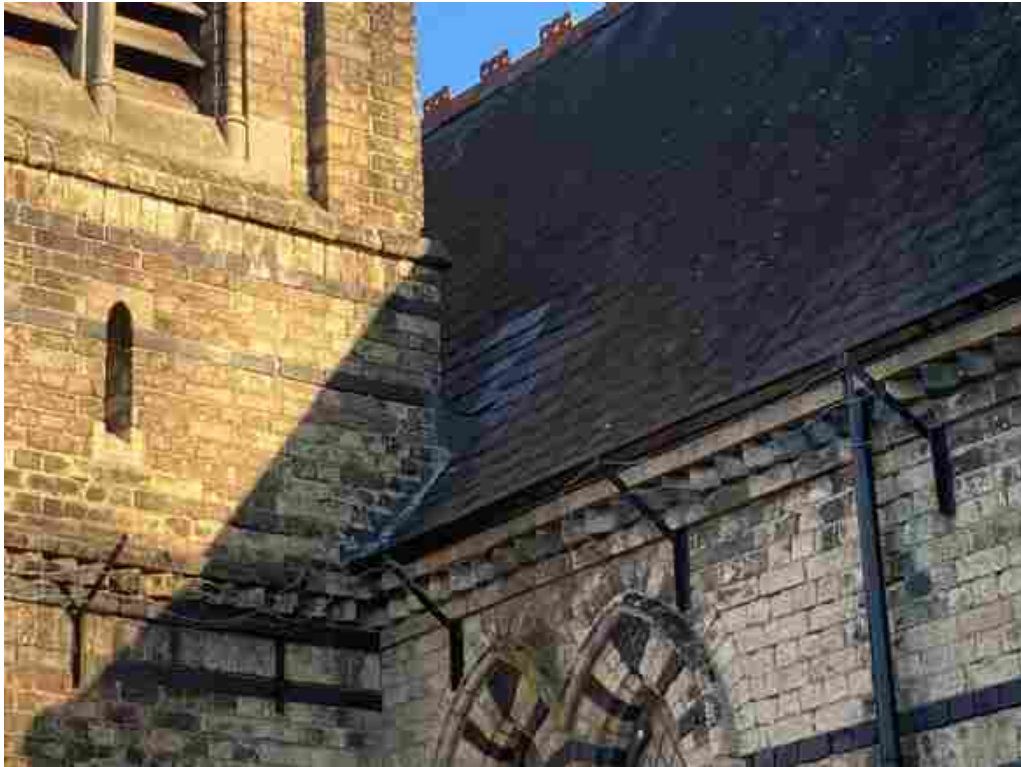
Area of later slates to Tower valley.

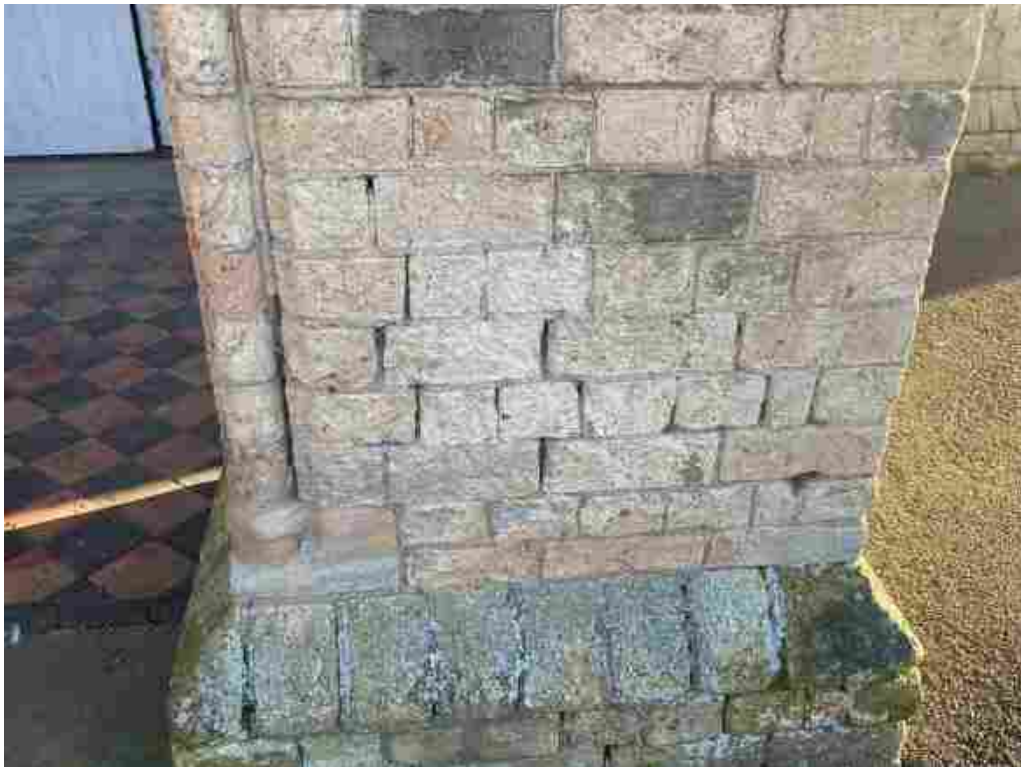
Open joints in cementitious mortar to Tower arch.

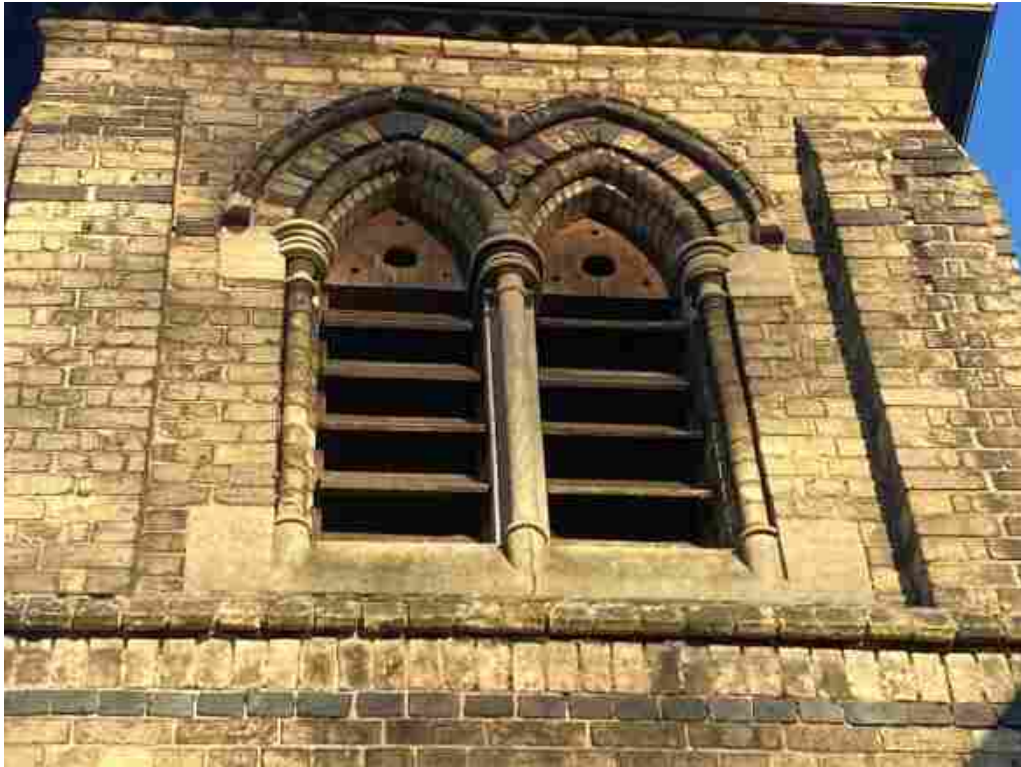
Belfry louvres could be meshed, repaired and redecorated.

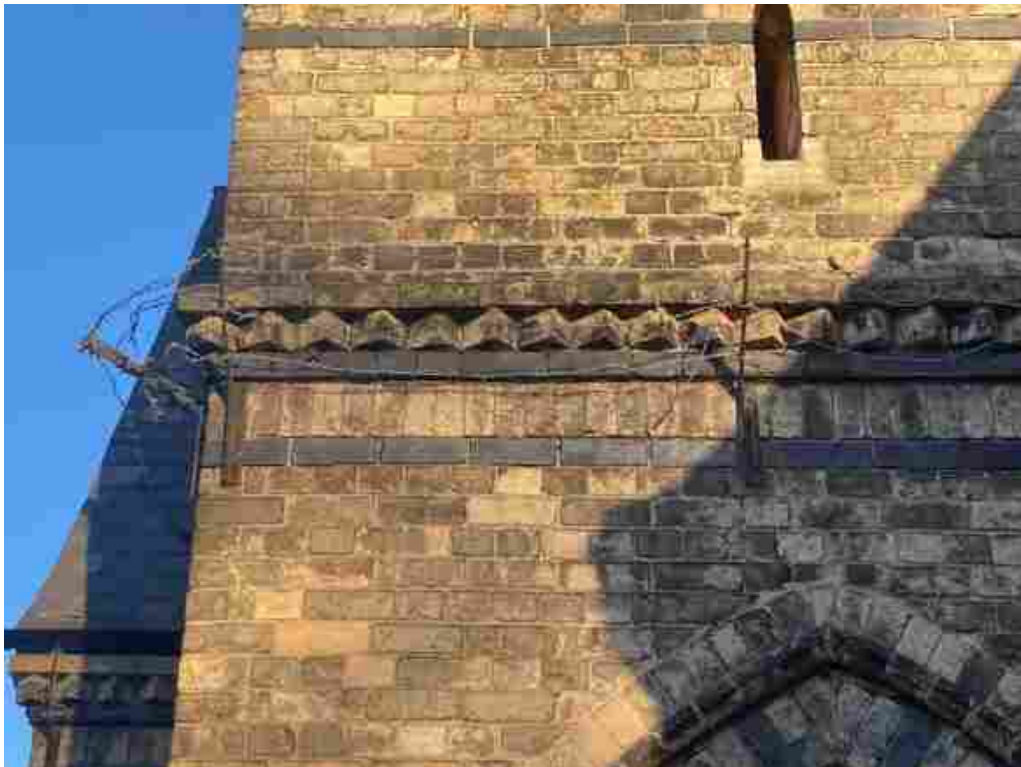
Barbed wire could be removed for an aesthetic improvement.

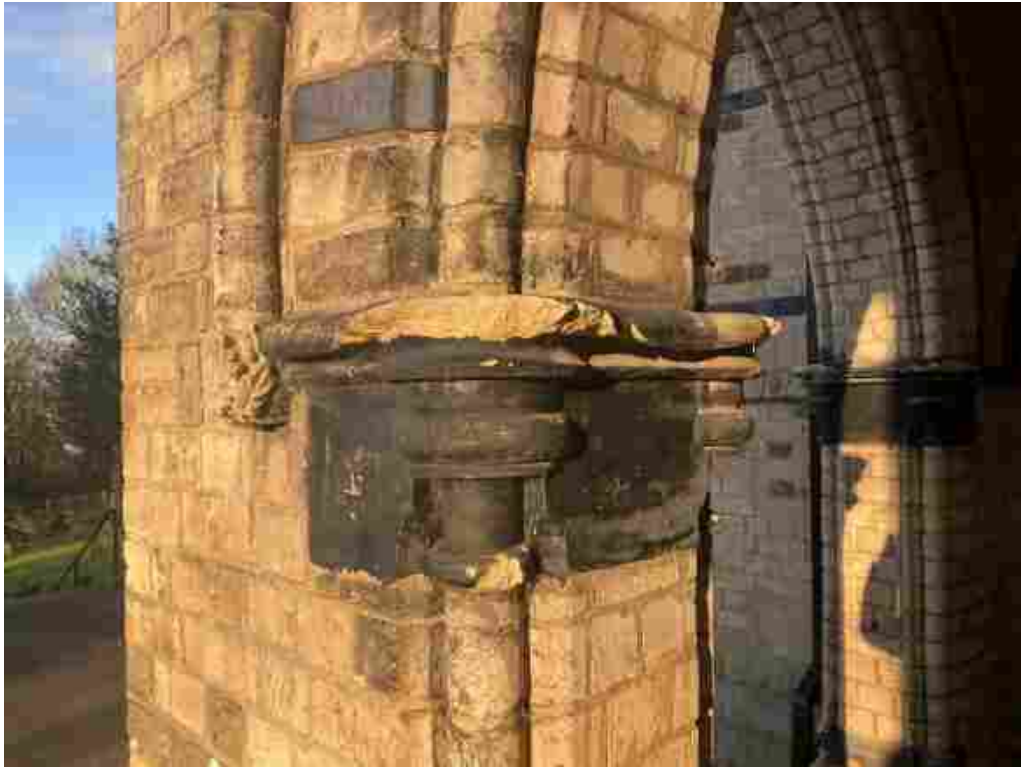
Stone decay to column capital.

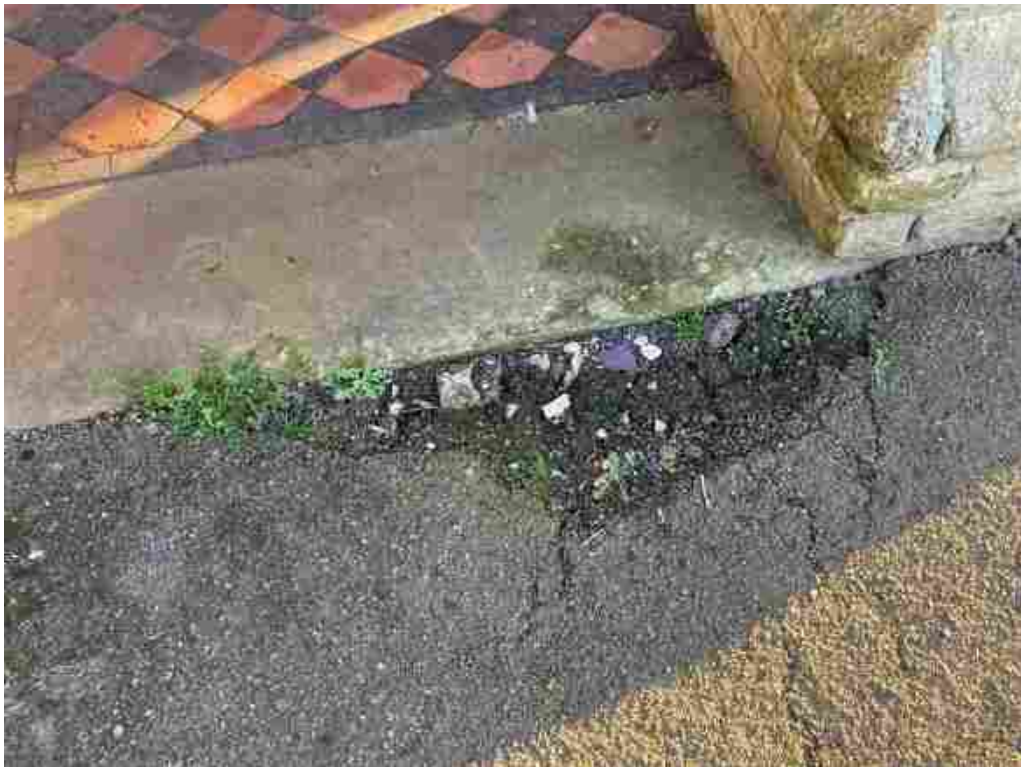
Failed section of asphalt.

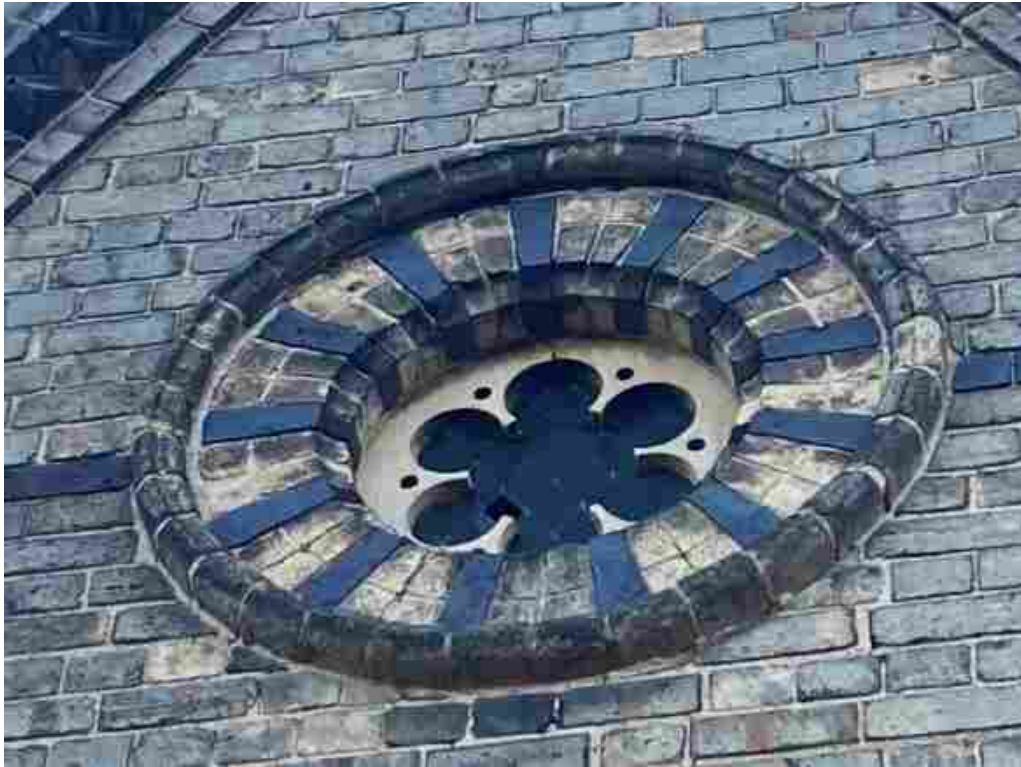
Missing quarry to round window on West elevation.

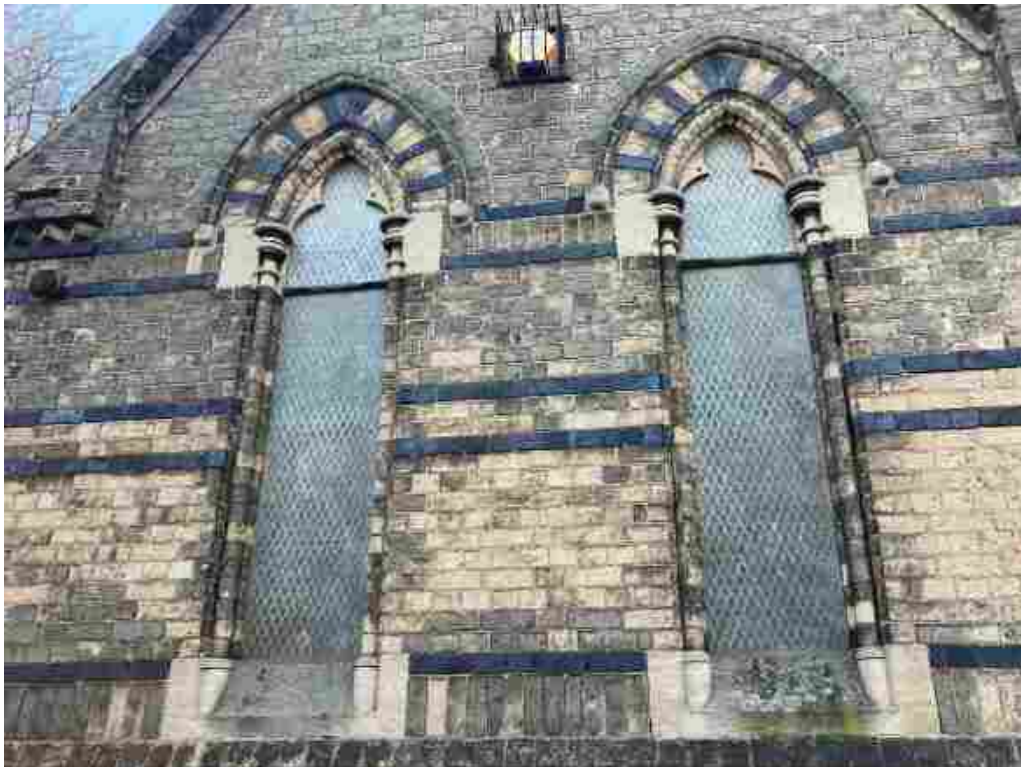
One major item of work required will be the replacement of the fibreglass windows with a more sympathetic intervention. Traditional leaded windows could be one option however a modern metal window (traditionally styled) may be a more practical and secure option.

Fibreglass windows should be replaced.

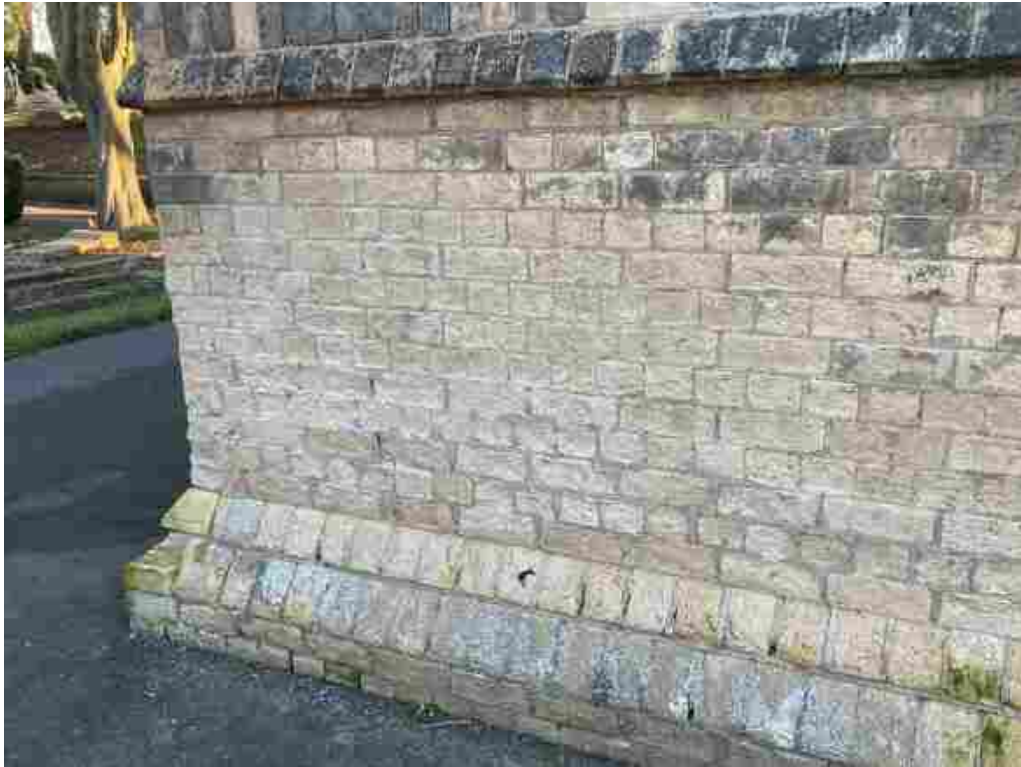
Cementitious pointing at low level should be removed and repointed.

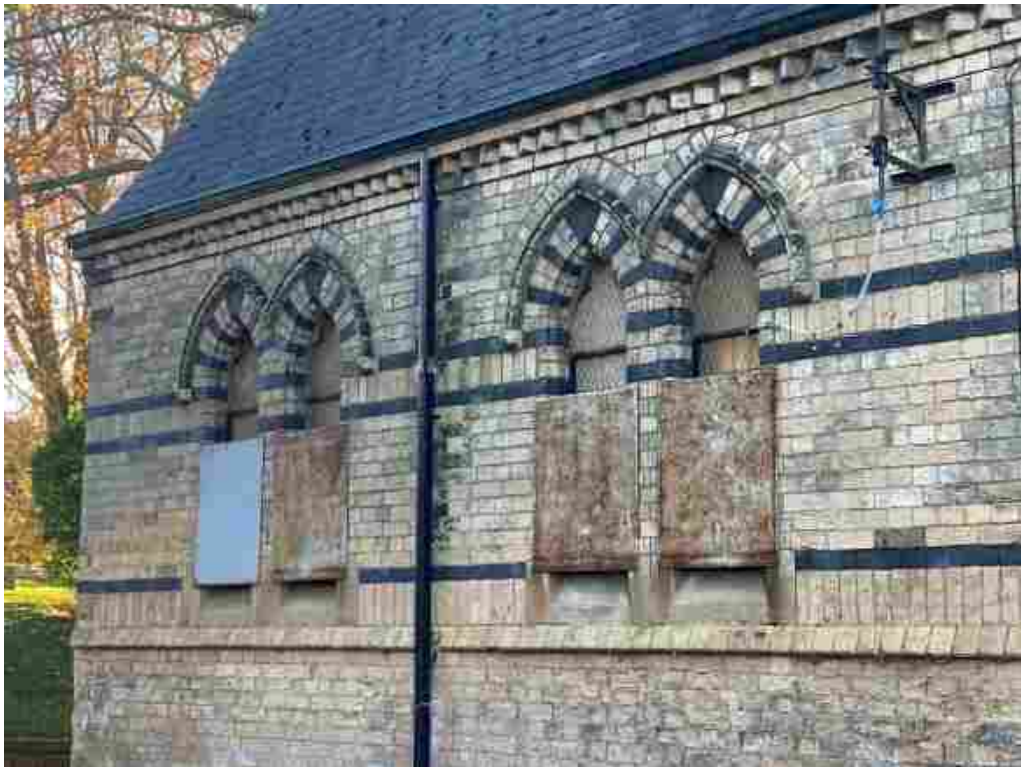
Security panels should be removed.

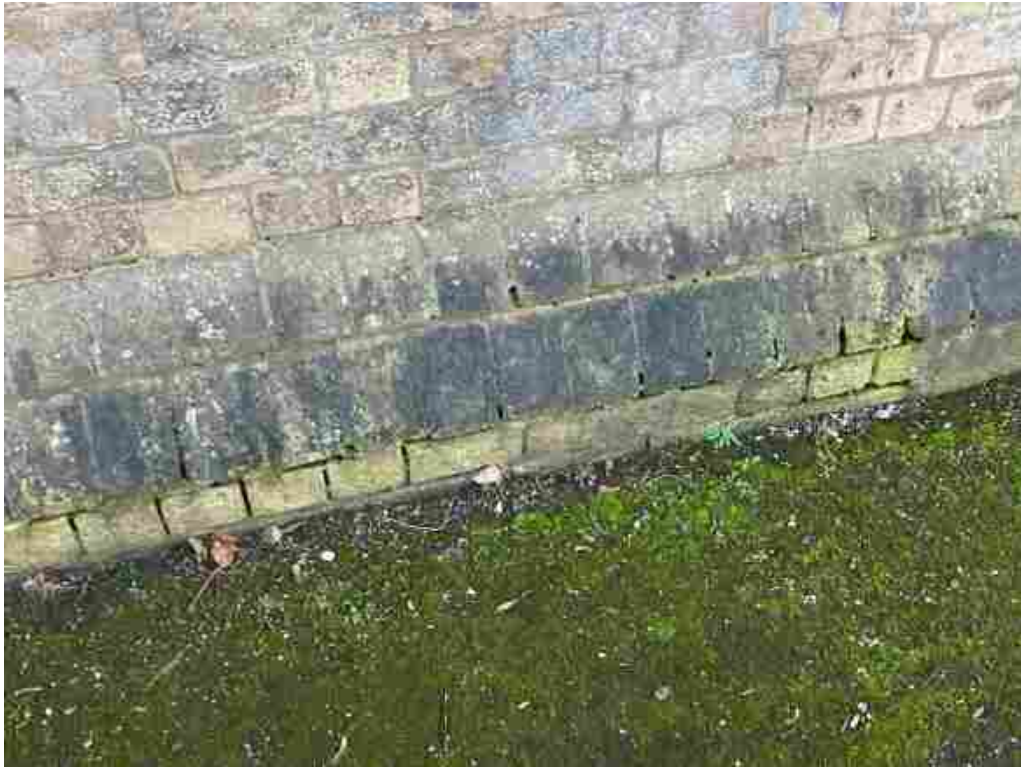
Open joints to plinth.

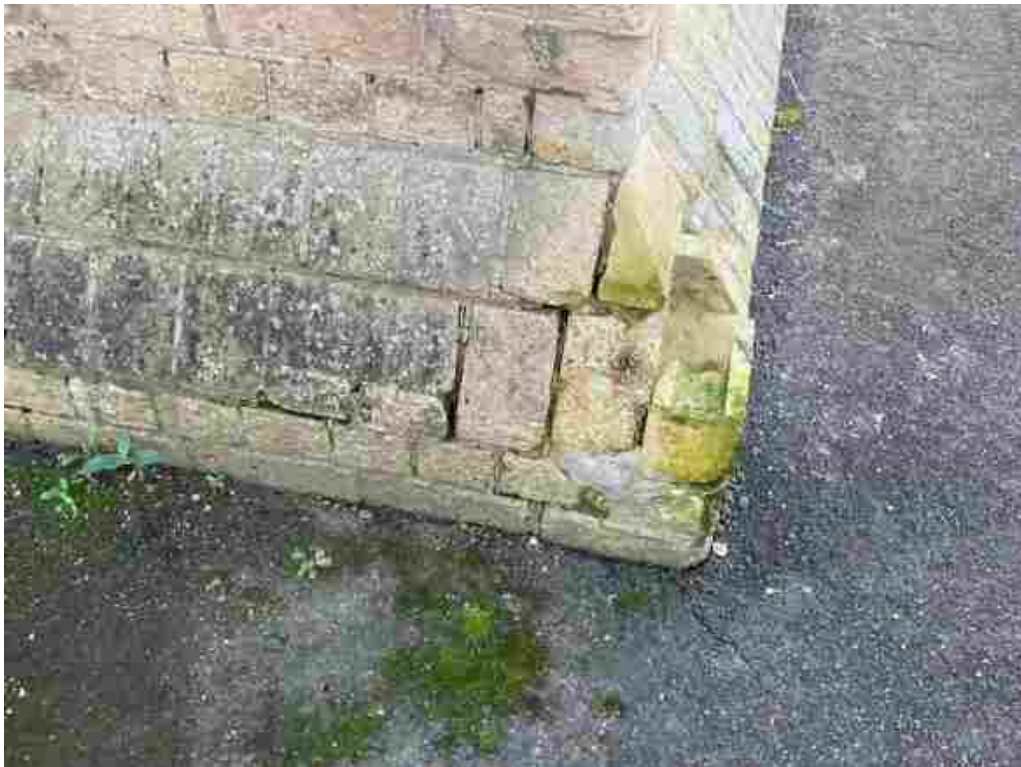
Section of missing brickwork to be rebuilt.

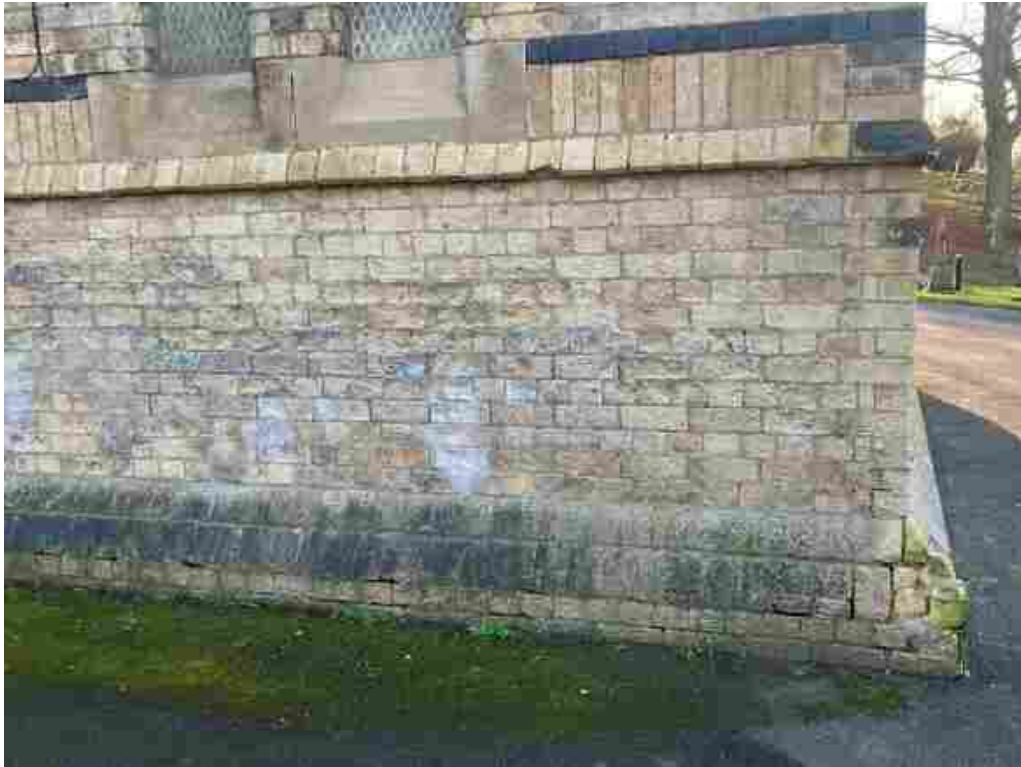
Band of cementitious mortar should be removed and repointed in lime.

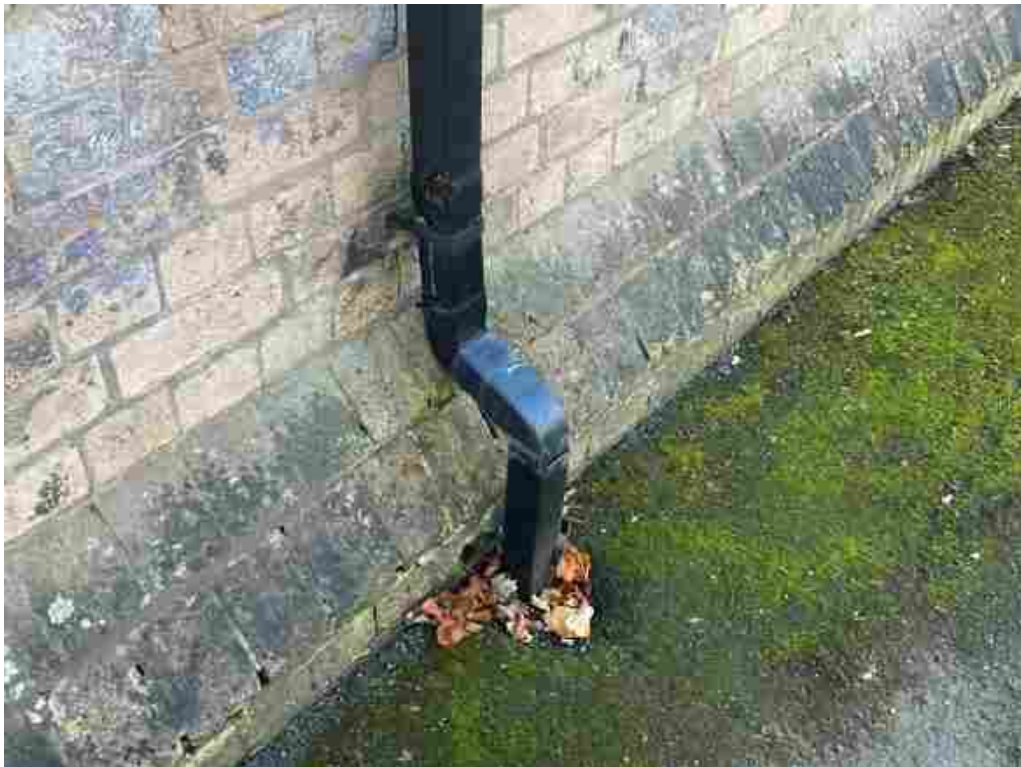
uPVC downpipes should be replaced with a more sympathetic material.

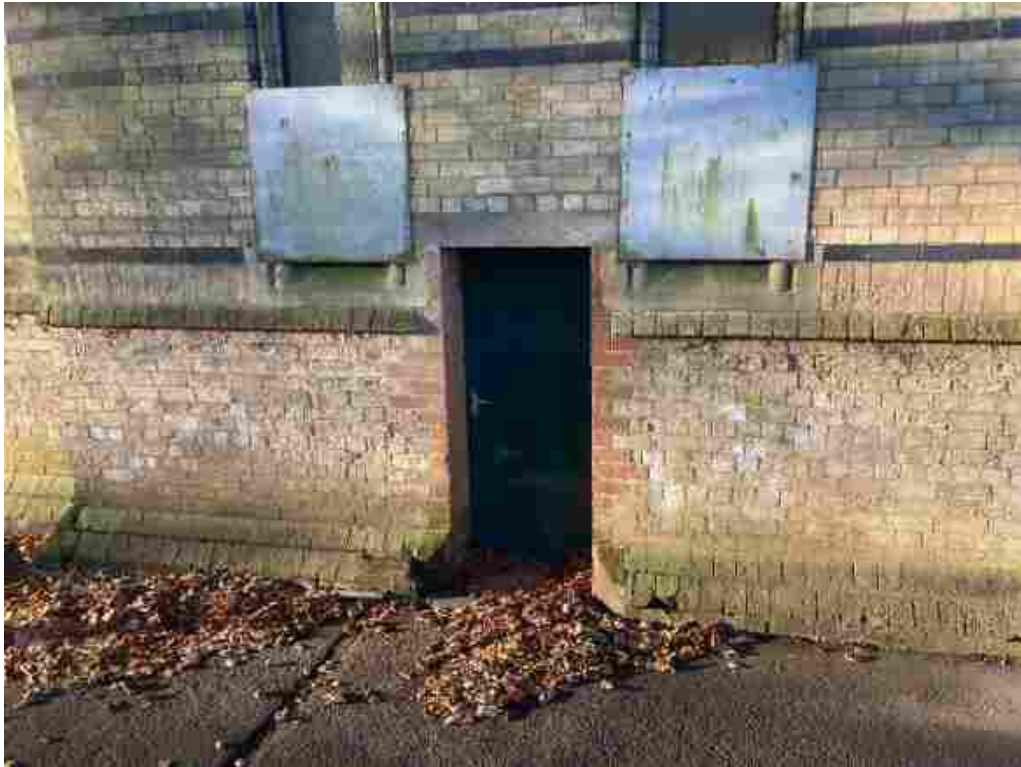
Later alteration of East elevation to introduce door.

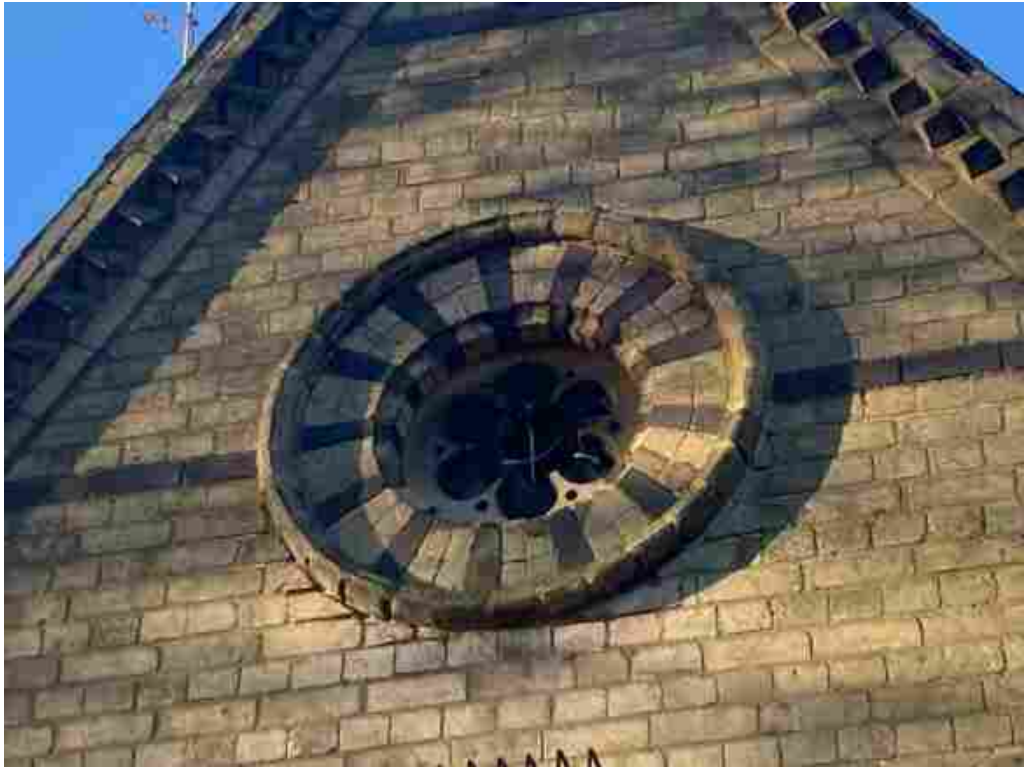
Broken round window on East elevation.

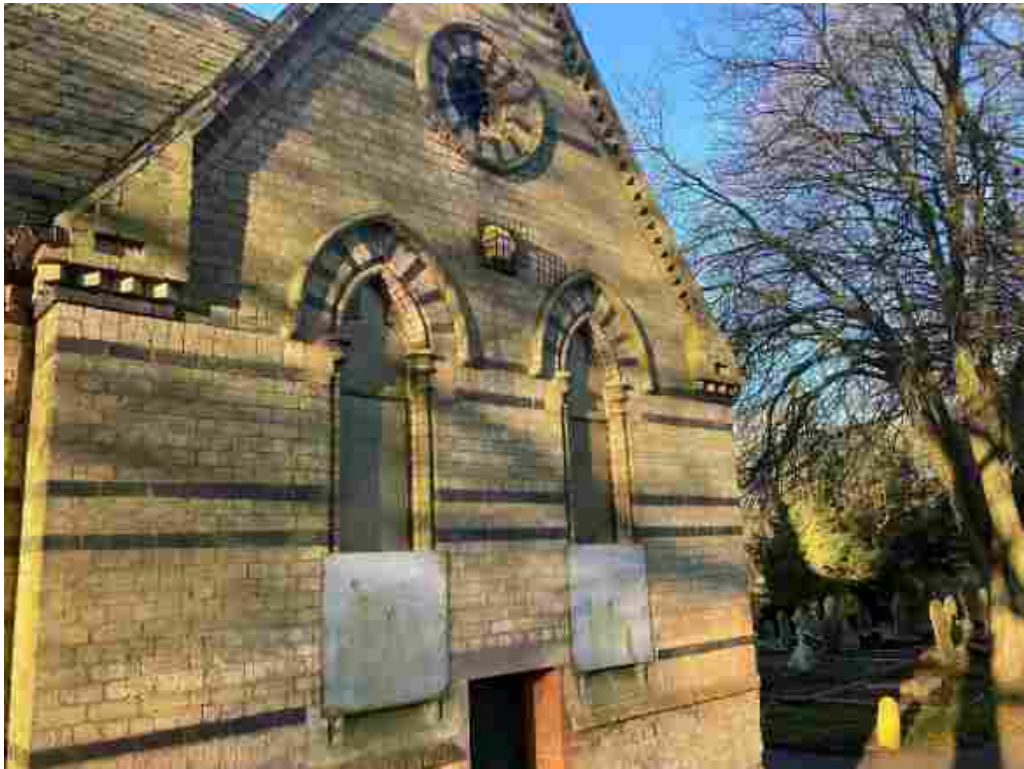
Algaeous growth to East elevation.

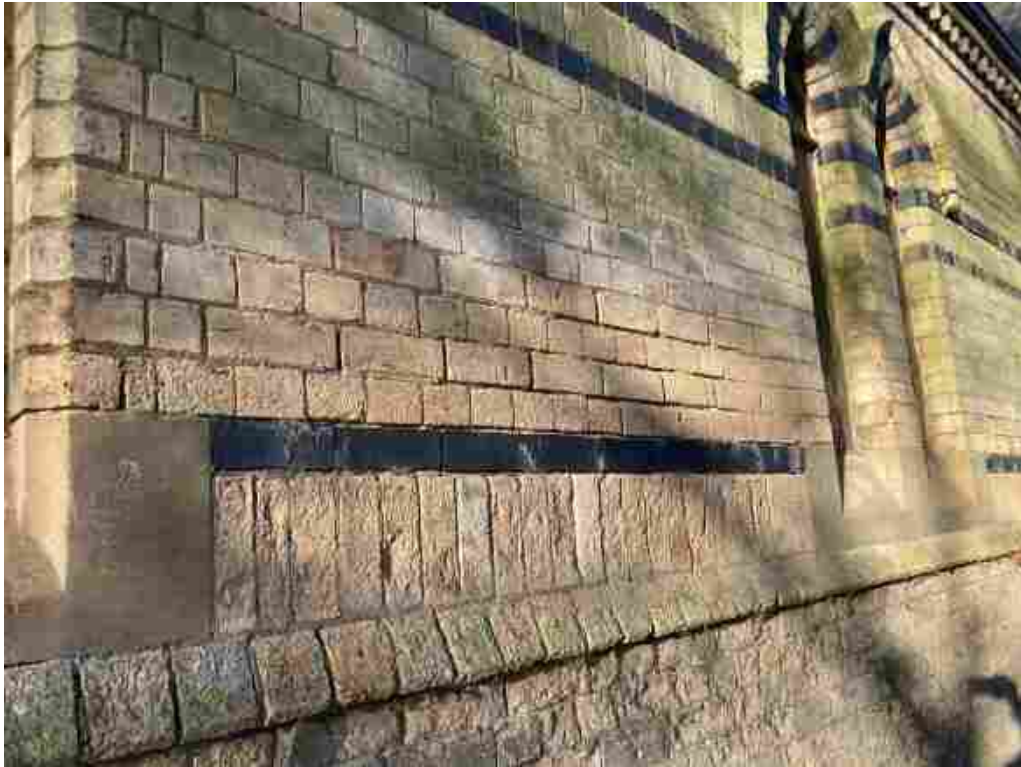
Open jointing to brickwork on East elevation.

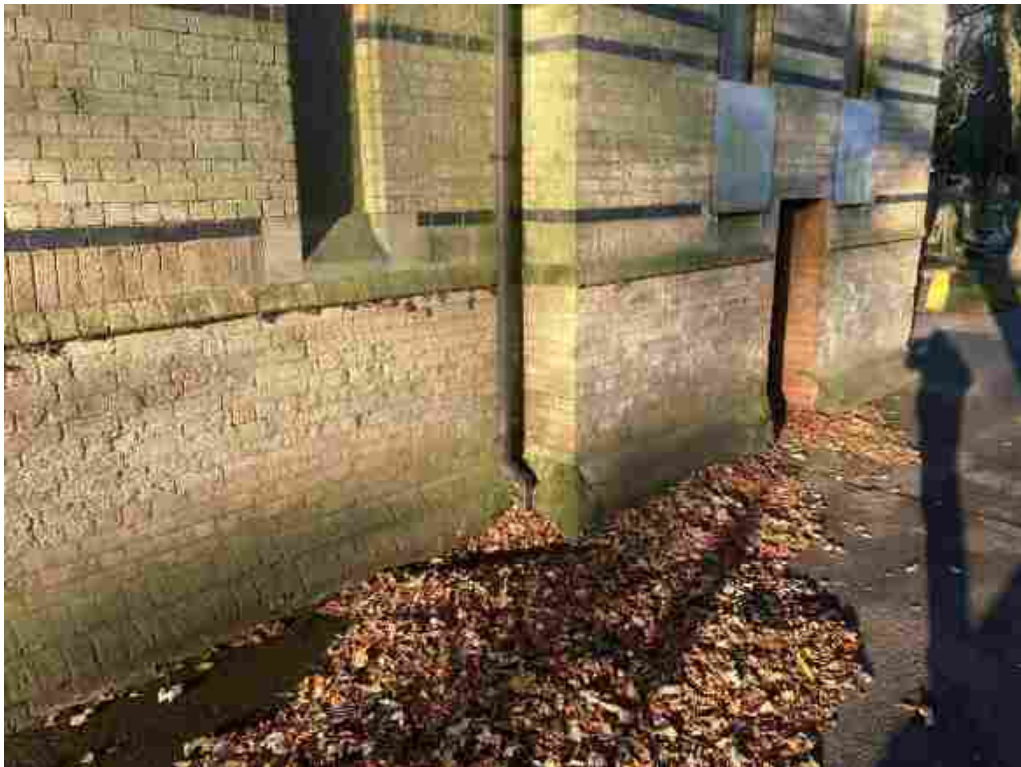
Leaves to gulleys should be cleared regularly.

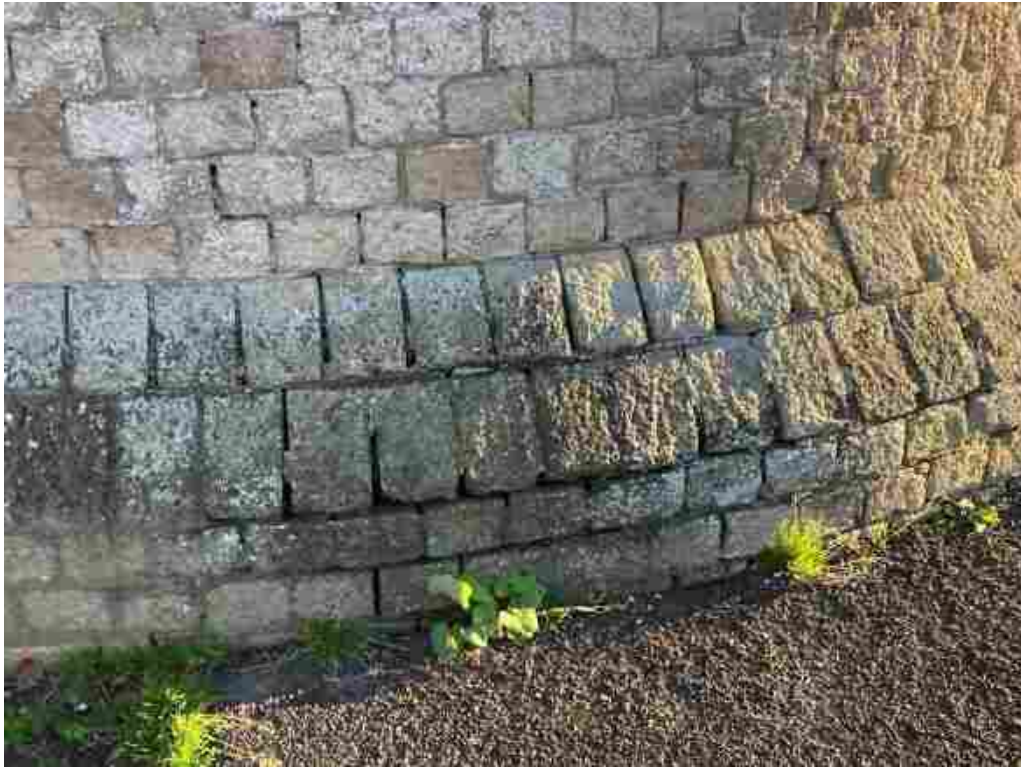
Open mortar joints to plinth.
