## PROPERTY AND SERVICES COMMITTEE AGENDA

**PS26/024 General Cemetery Chapel Condition Survey**

### Condition Report

Inspected by:  
Daniel Elkington BArch(Hons) MArch ARB RIBA FHEA  
24<sup>th</sup> November 2023

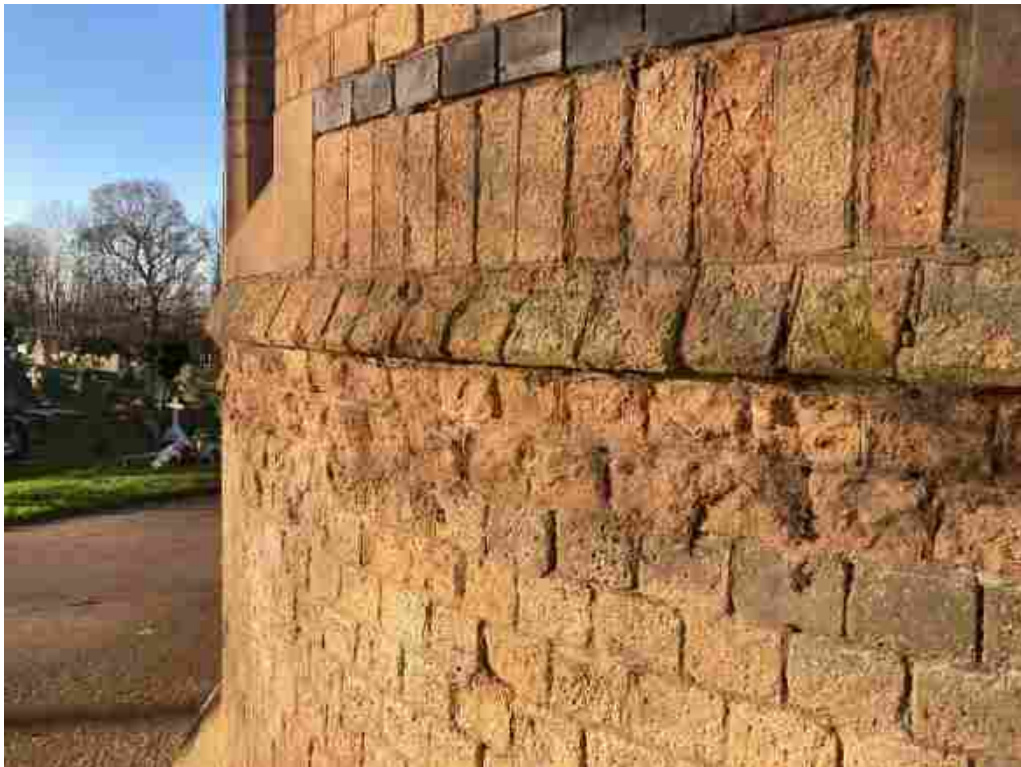
Area of brickwork replacements and pointing required.

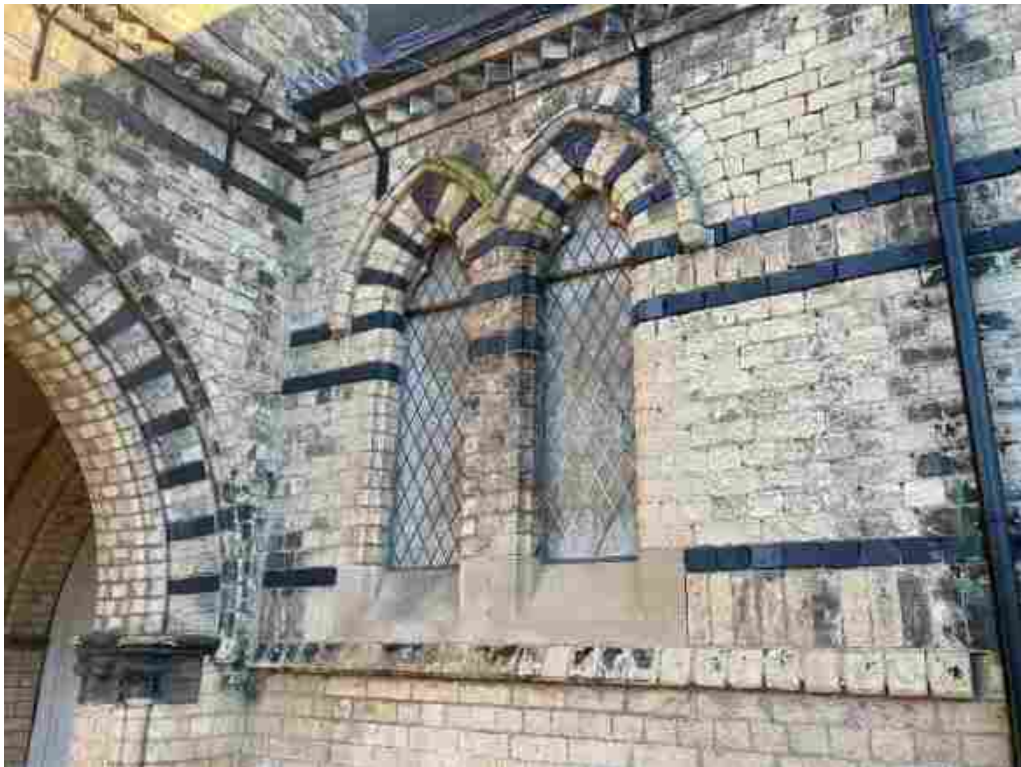
Fibreglass windows should be replaced.

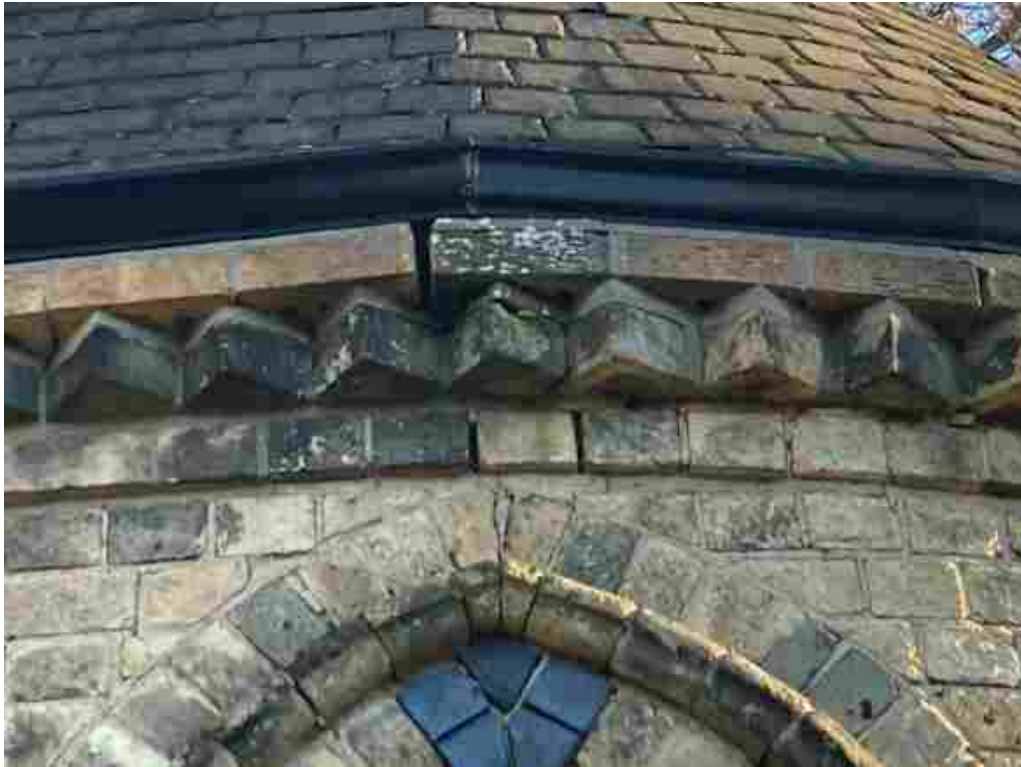
Crack to head of window extending up into the dogtooth brick cornice.

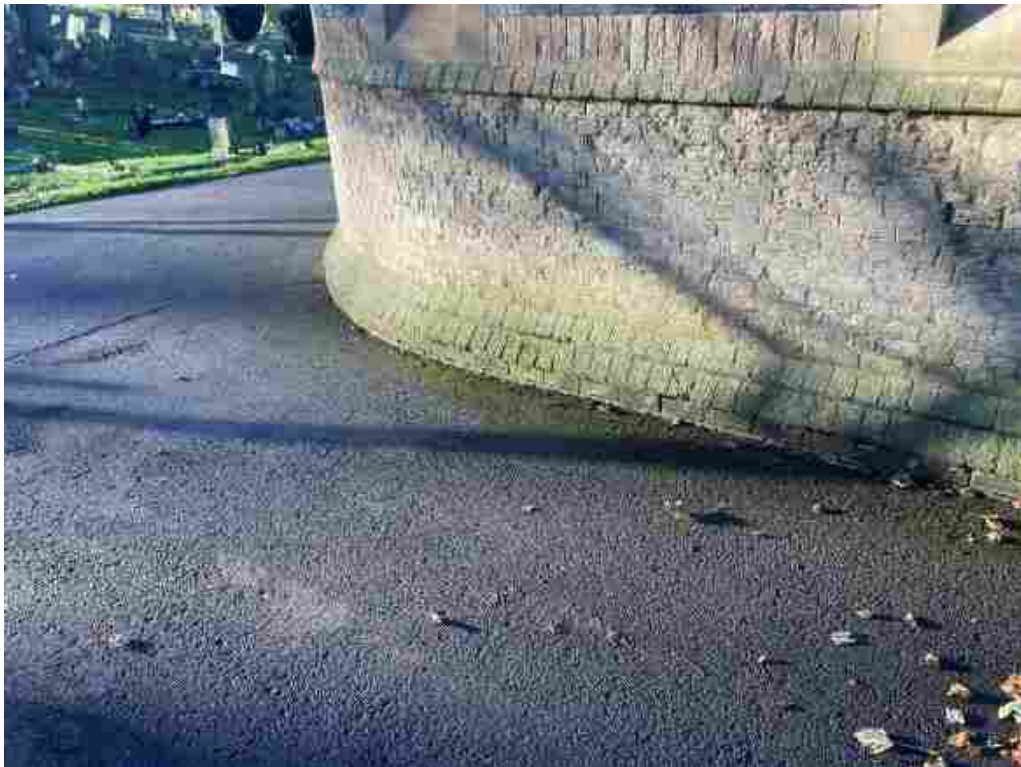
Asphalt has been installed up to the base of the wall, trapping moisture against the building.

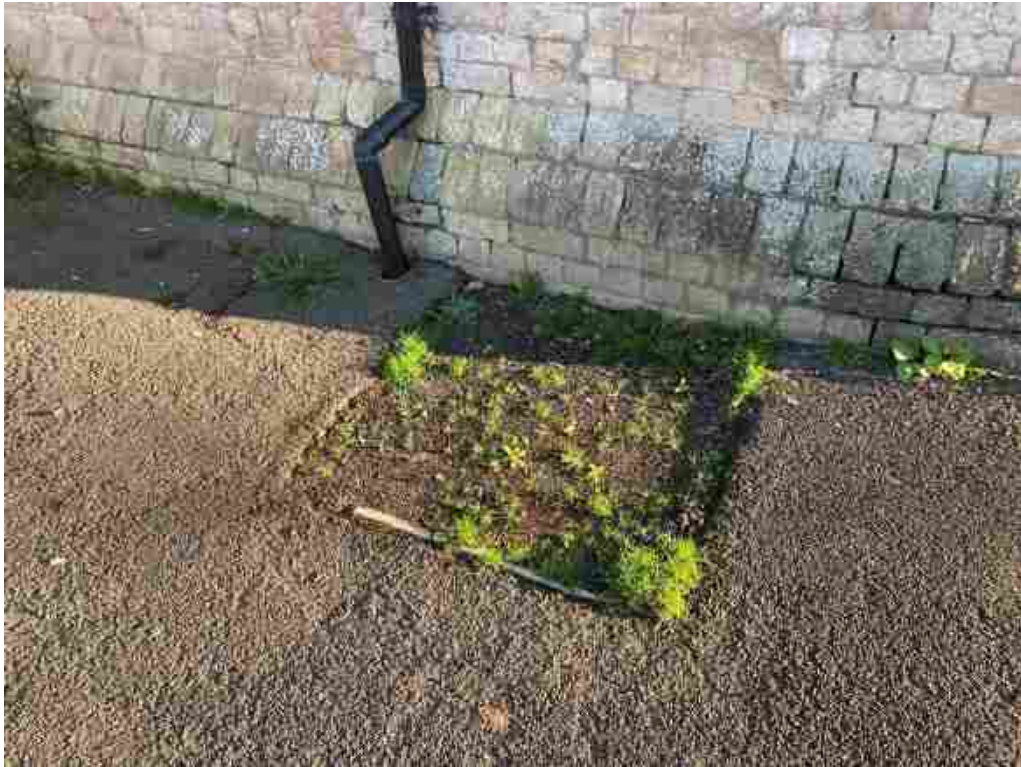
Area to be investigated.

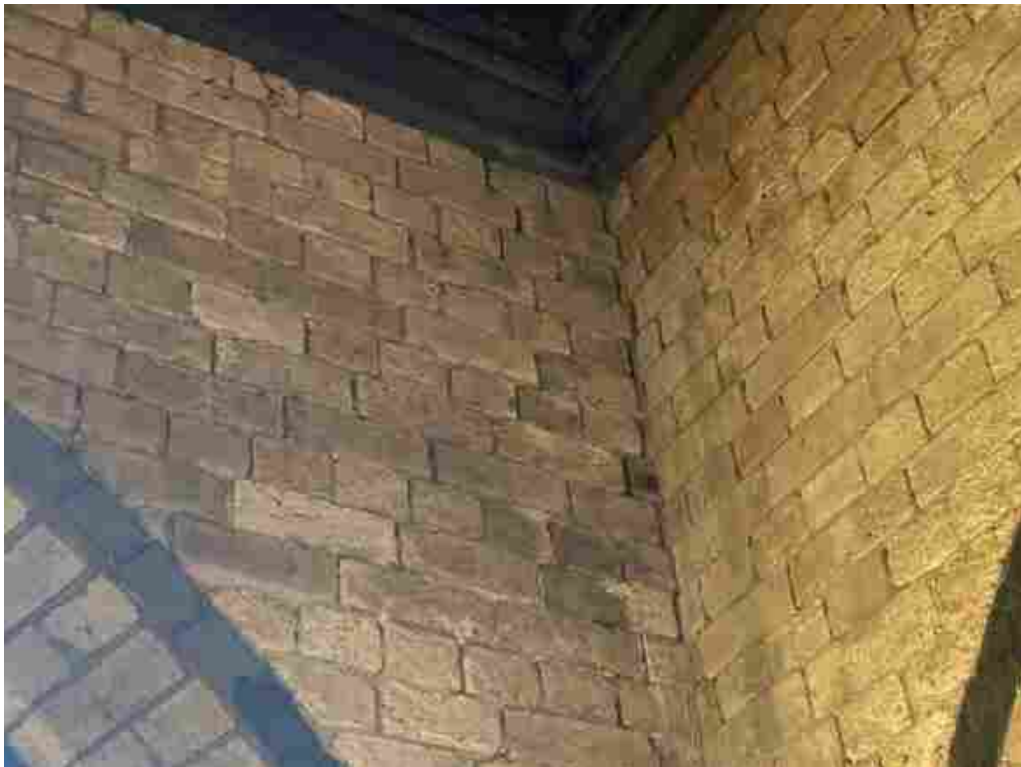
Recessed joints to the Tower base.

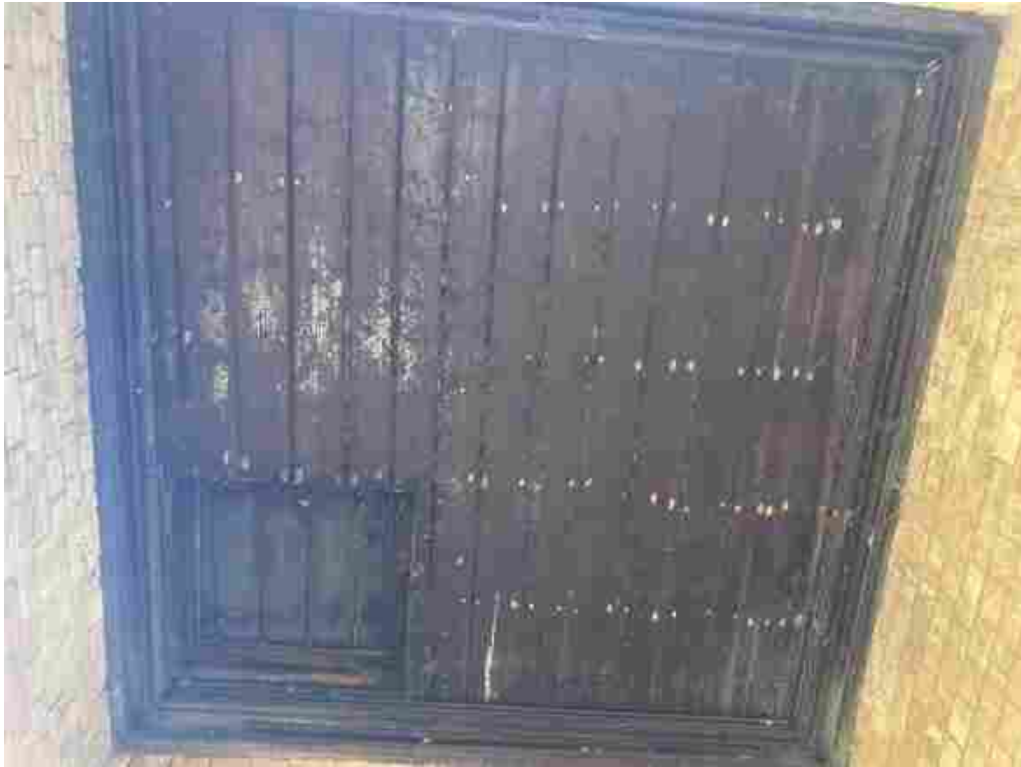
The condition of the Belfry interior remains unknown and access should be provided so this can be assessed.

Further access should be given to investigate Belfry condition.

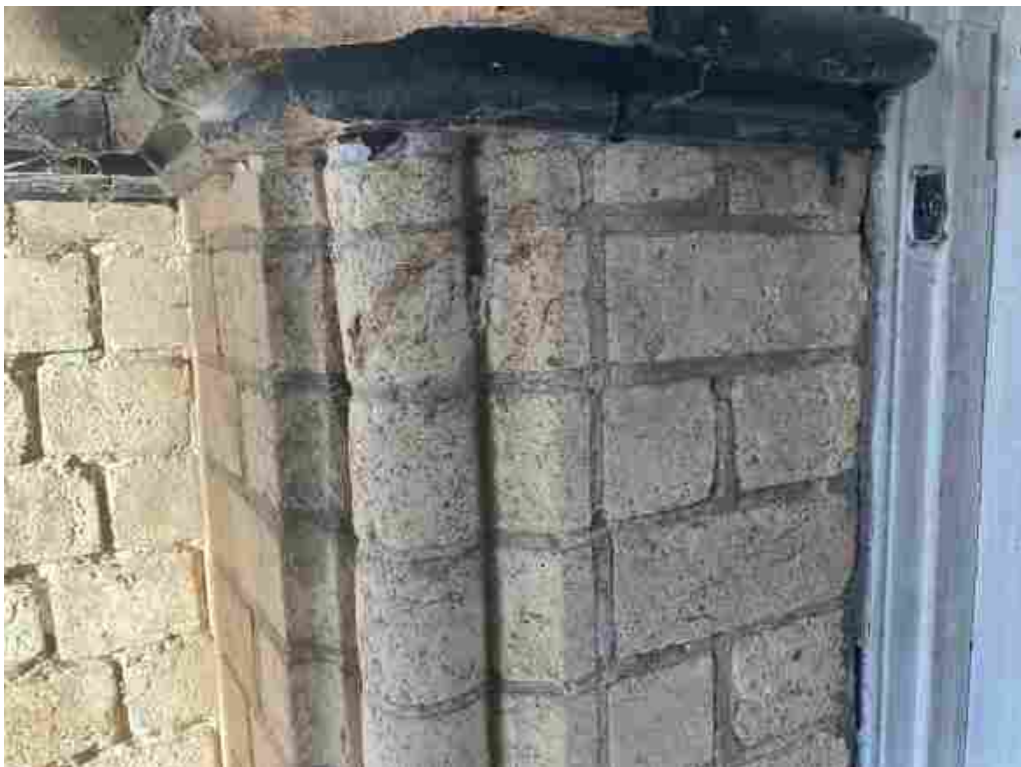
Cementitious mortar to the compound column profile.

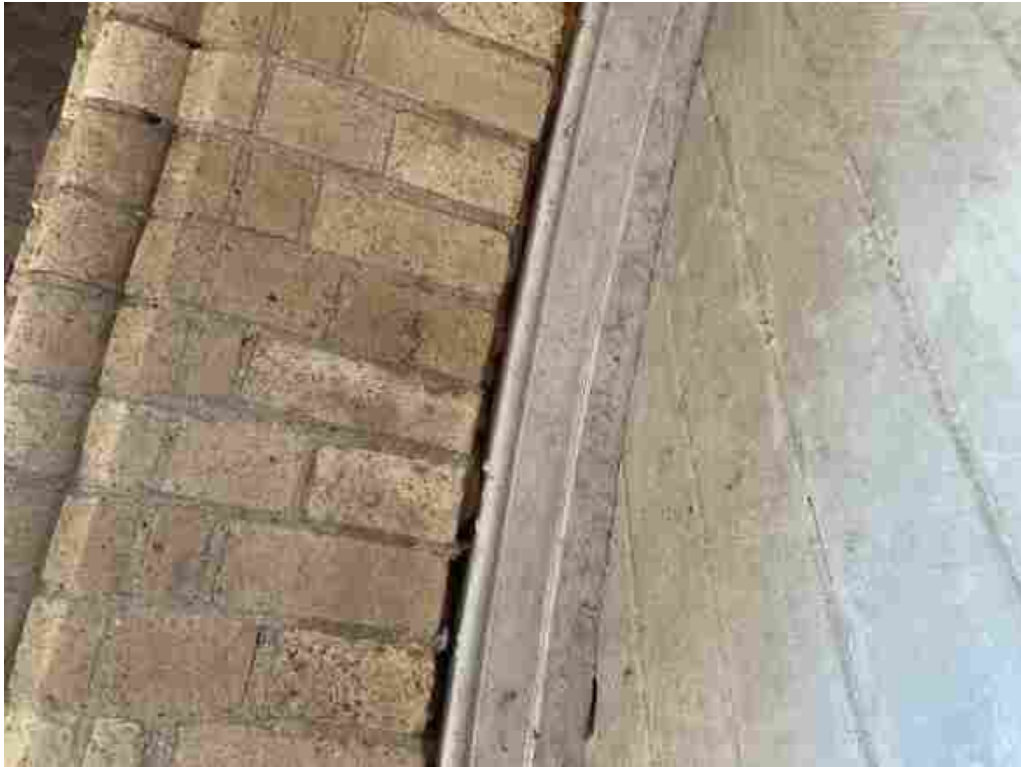
Missing mortar to doors/brickwork junction.

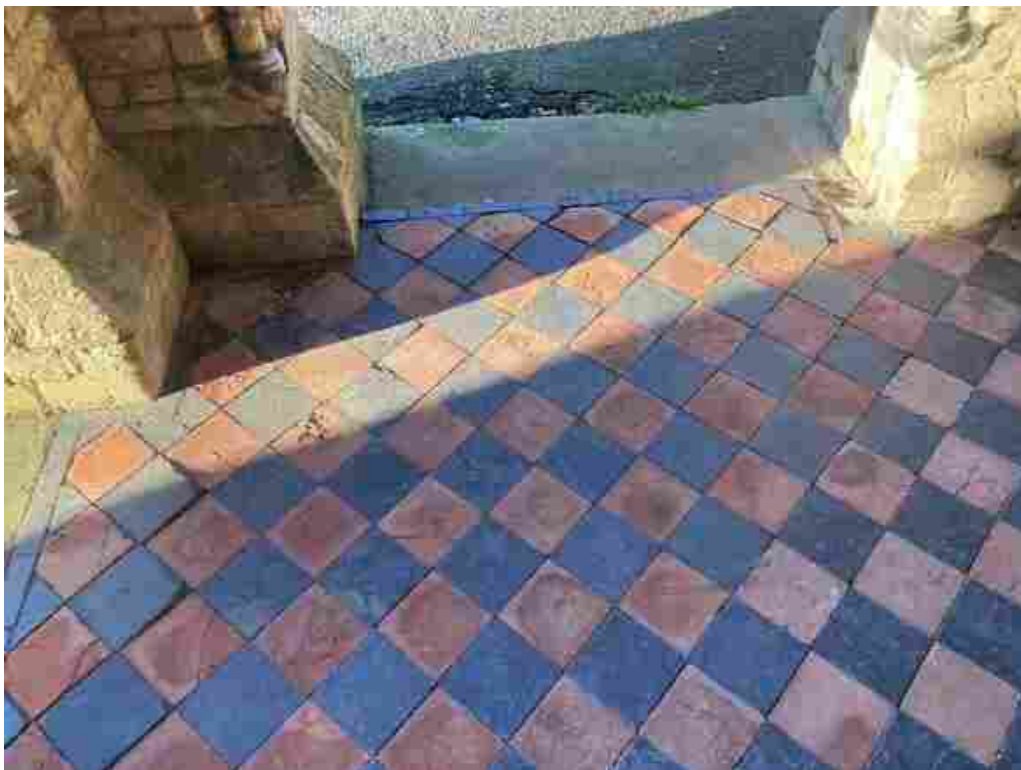
Decay and unevenness to quarry tiles.

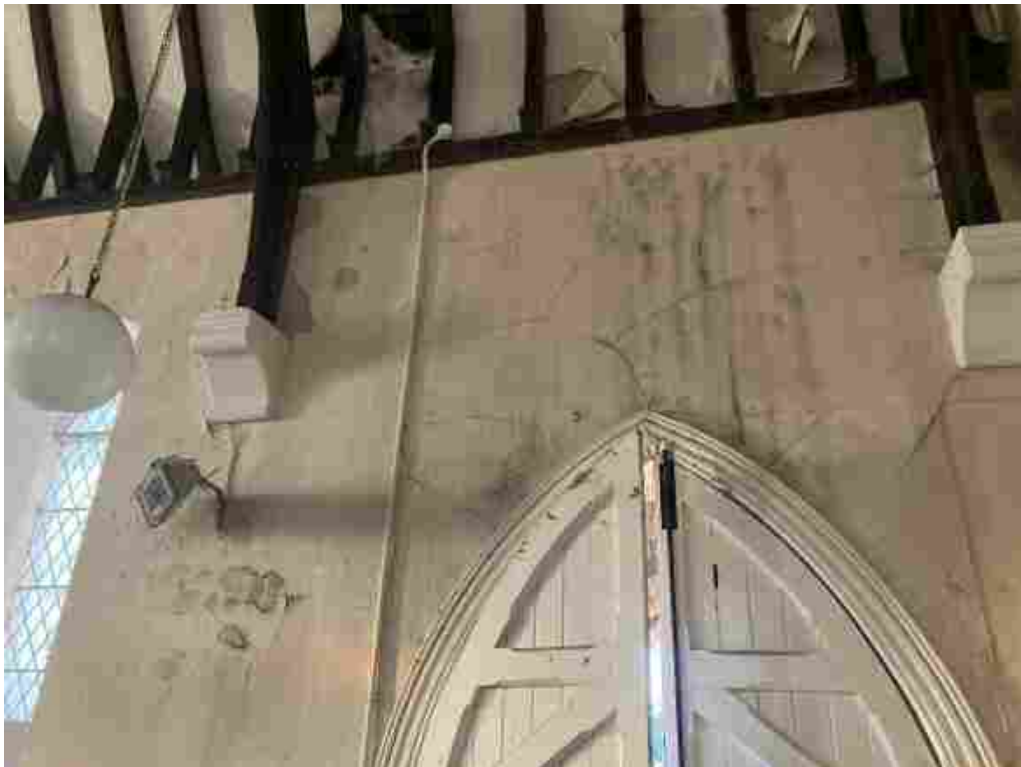
Widespread mould growth and failing paintwork.

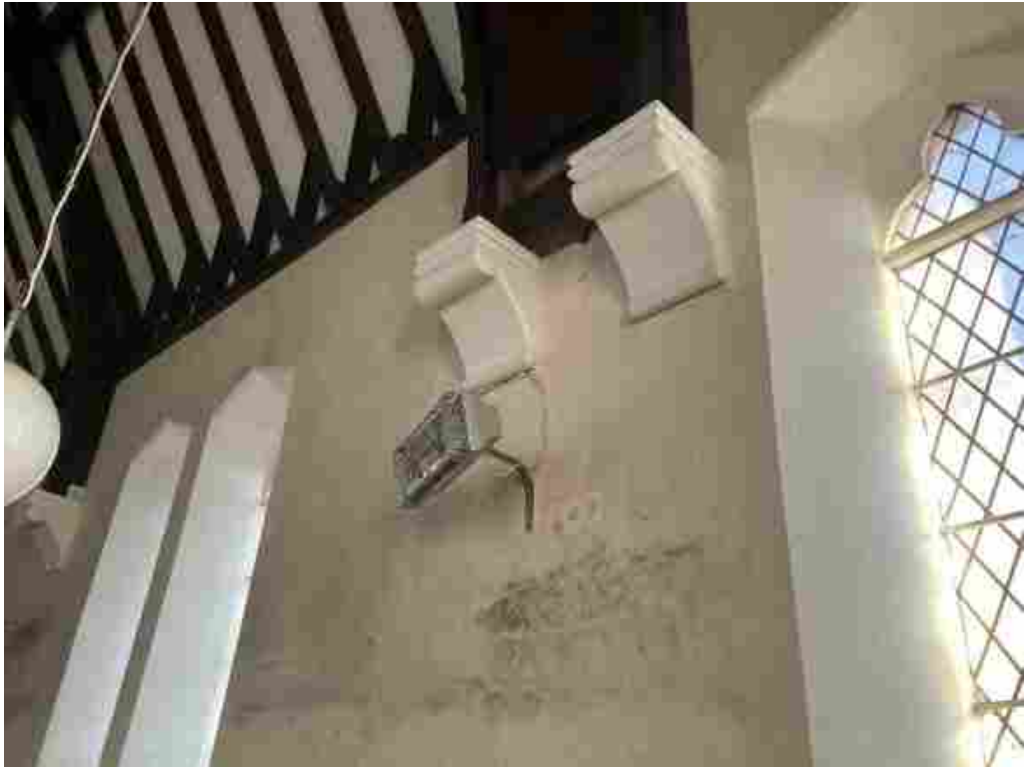
Infrared heating system to be replaced.

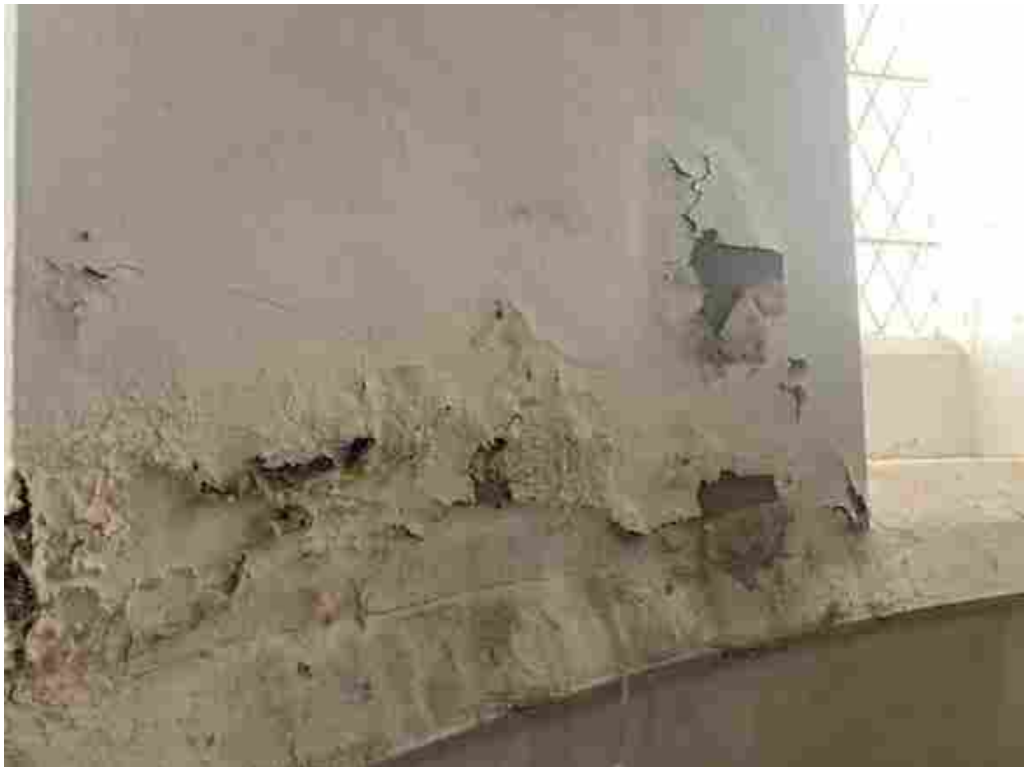
The condition of the interior of the building is significantly worse than the exterior and the building is suffering from numerous damp related issues. Primary of these is the extensive use of cementitious render internally. This is not allowing the building to breathe, as should happen with traditionally constructed buildings, and moisture is unable to escape. This is exacerbated by a lack of heat and ventilation to the building through non-use.

Cementitious render is causing widespread issues with damp.

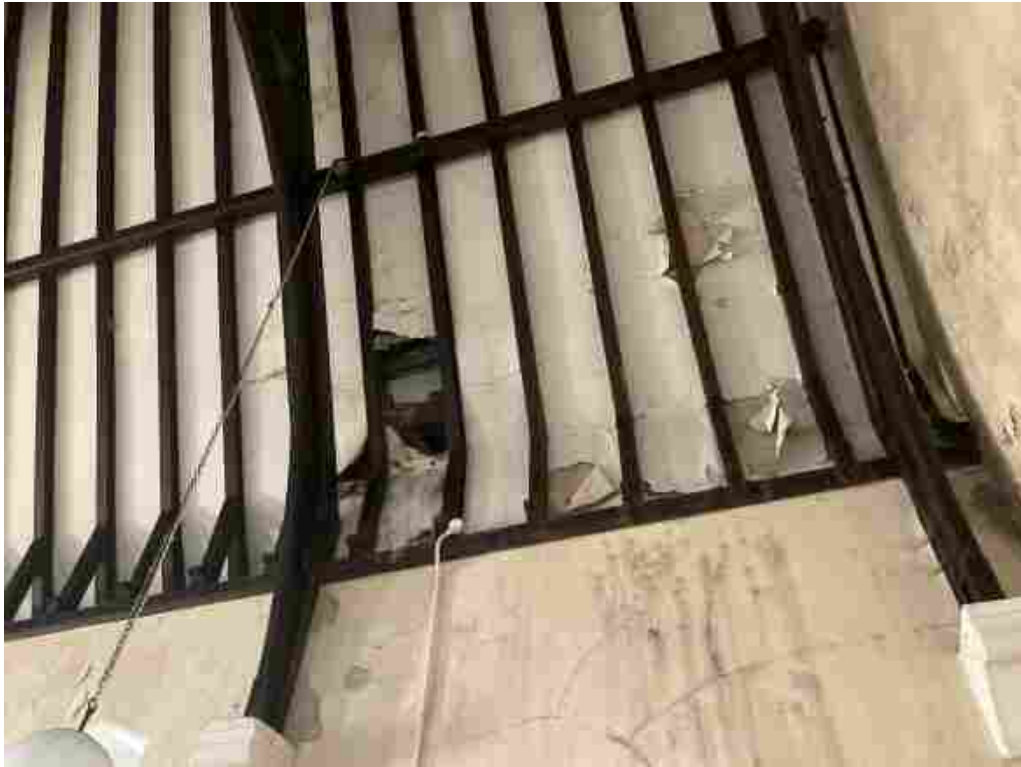
Failing paint and plaster panels to the ceiling.

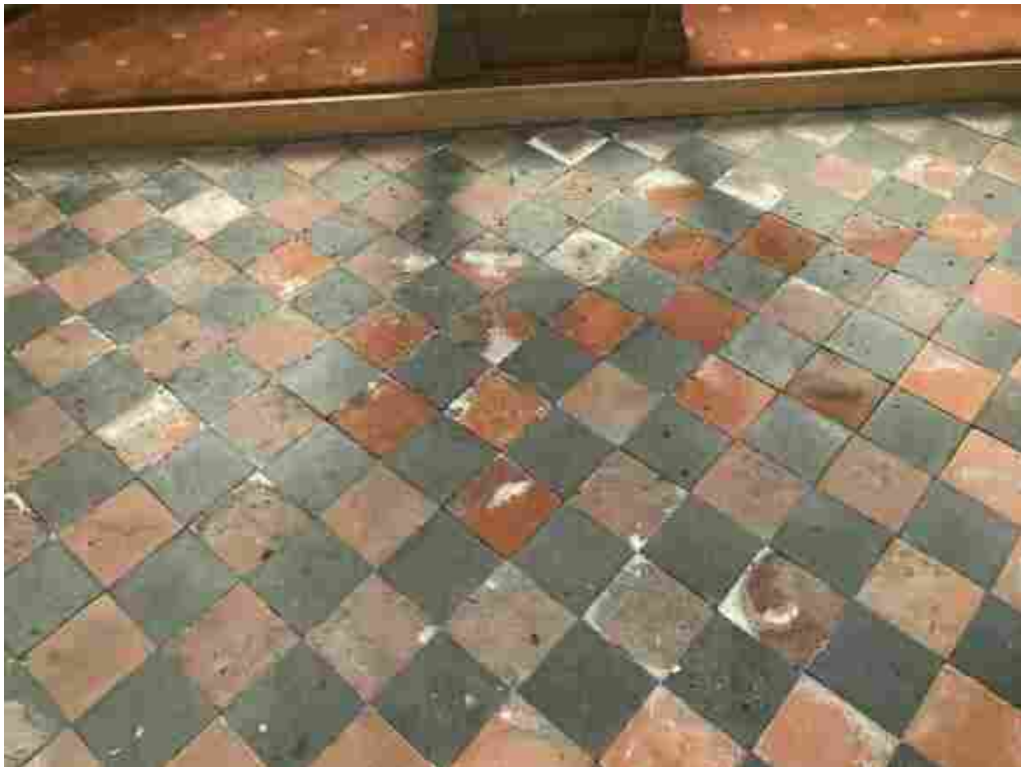
Decay to Chapel quarry tiles.

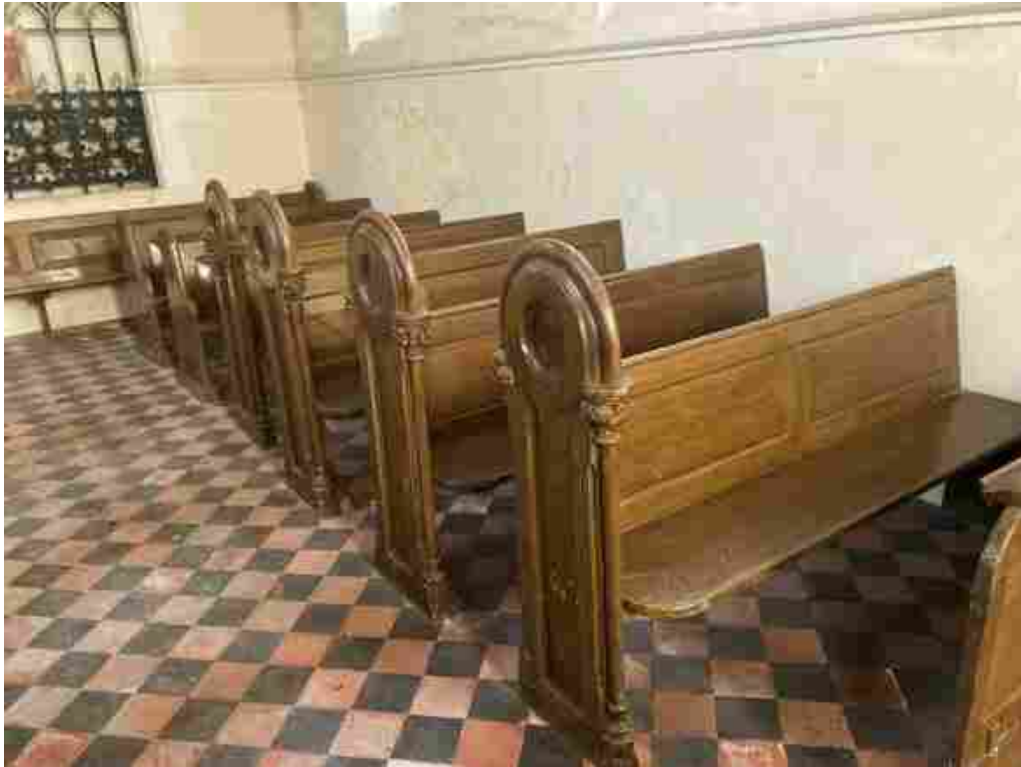
Some pews are loose. A more flexible seating option could be considered.

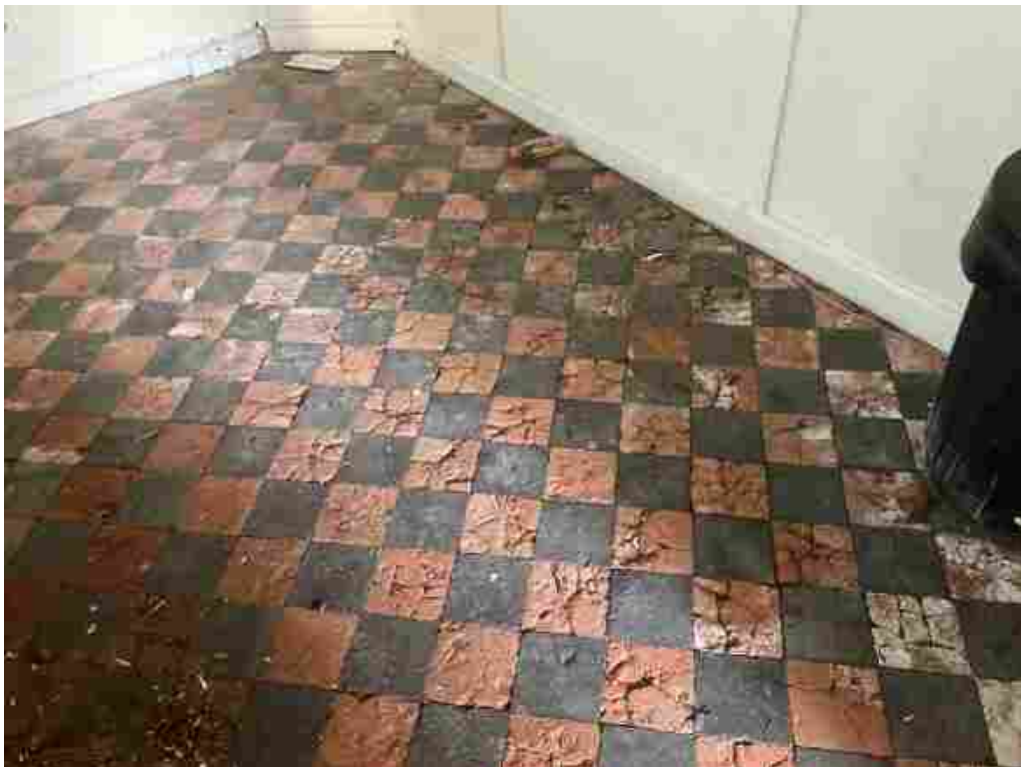
Severe decay and salting to quarry tiles in Meeting Room.

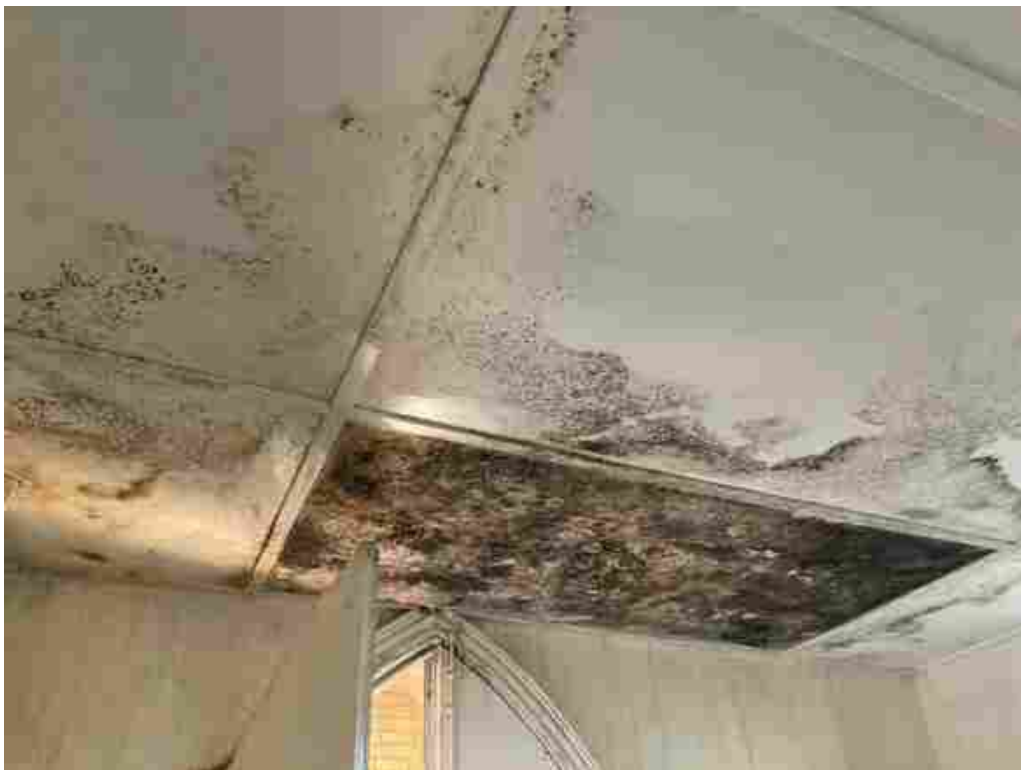
Heavy mould growth and water ingress to suspended ceiling.

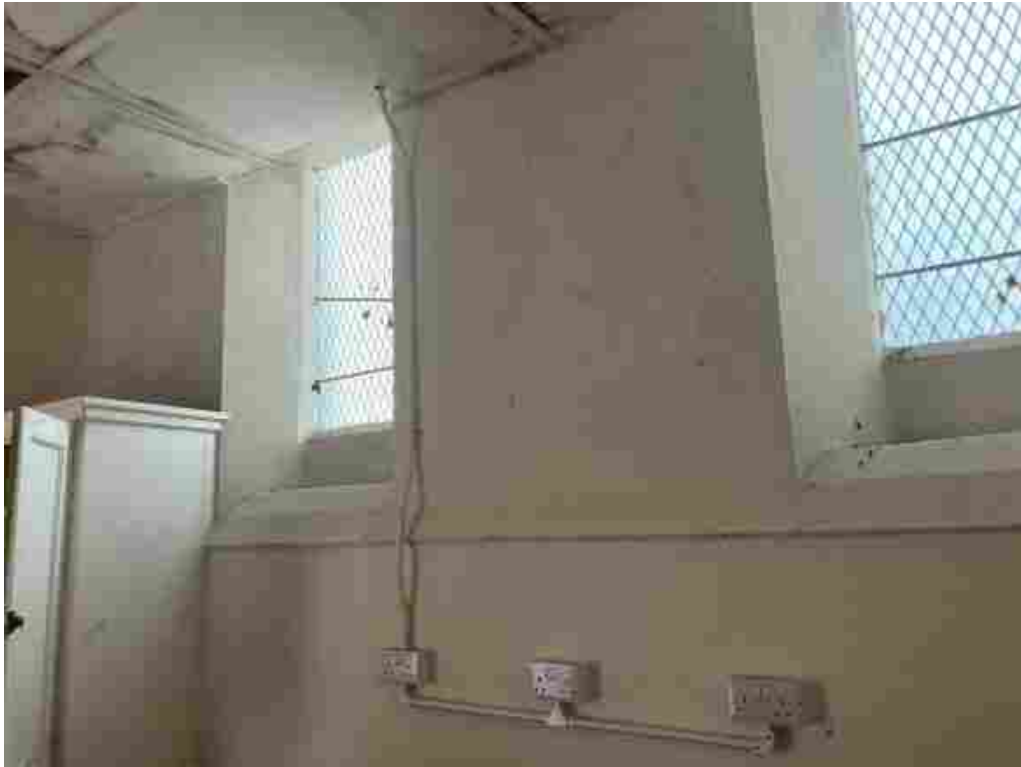
Cementitious render has also been used internally.

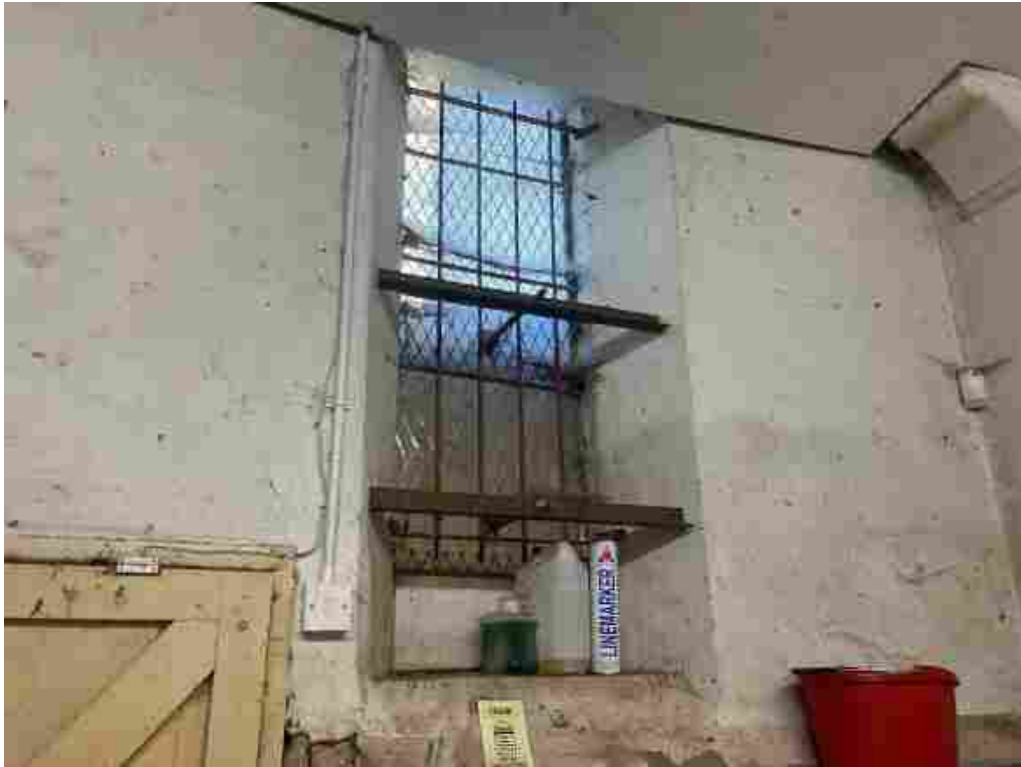
Fibreglass windows should be replaced.

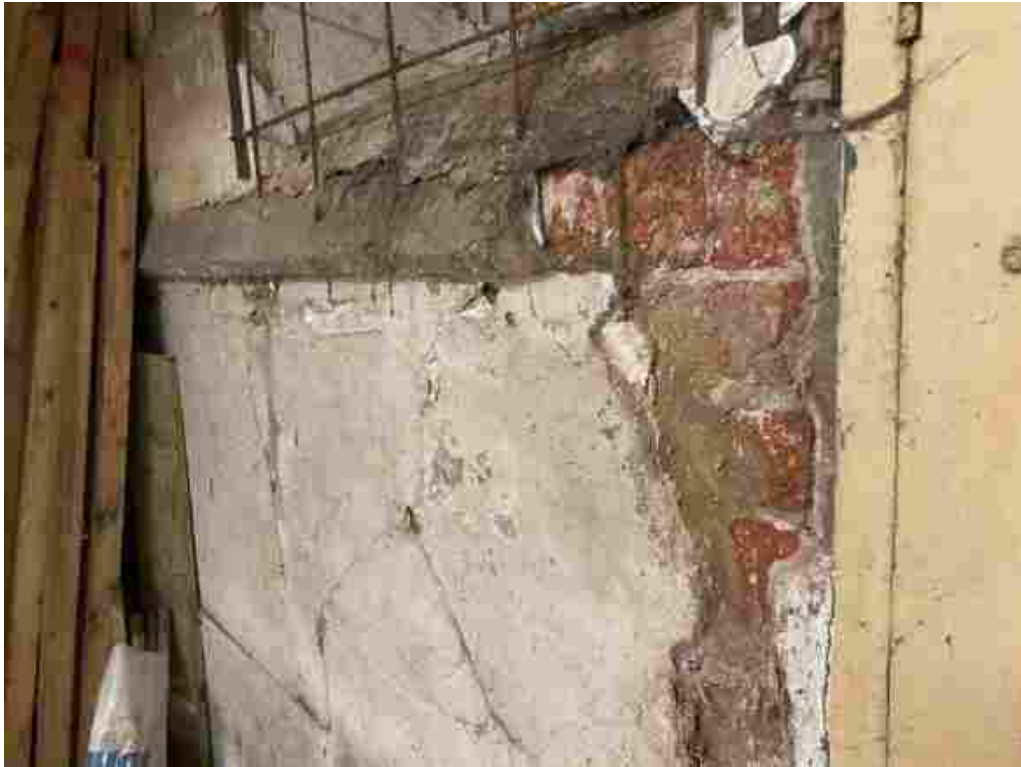
Cementitious render has also been used in this area, which should be removed.

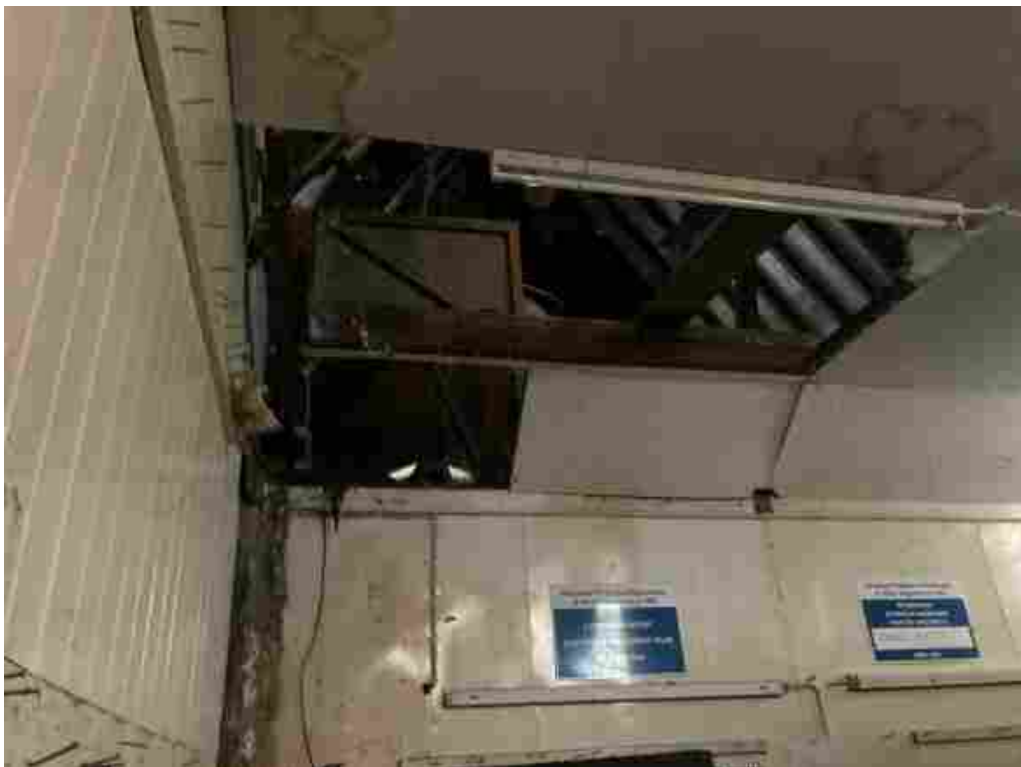
Further investigations should be undertaken when partitions removed or access provided.

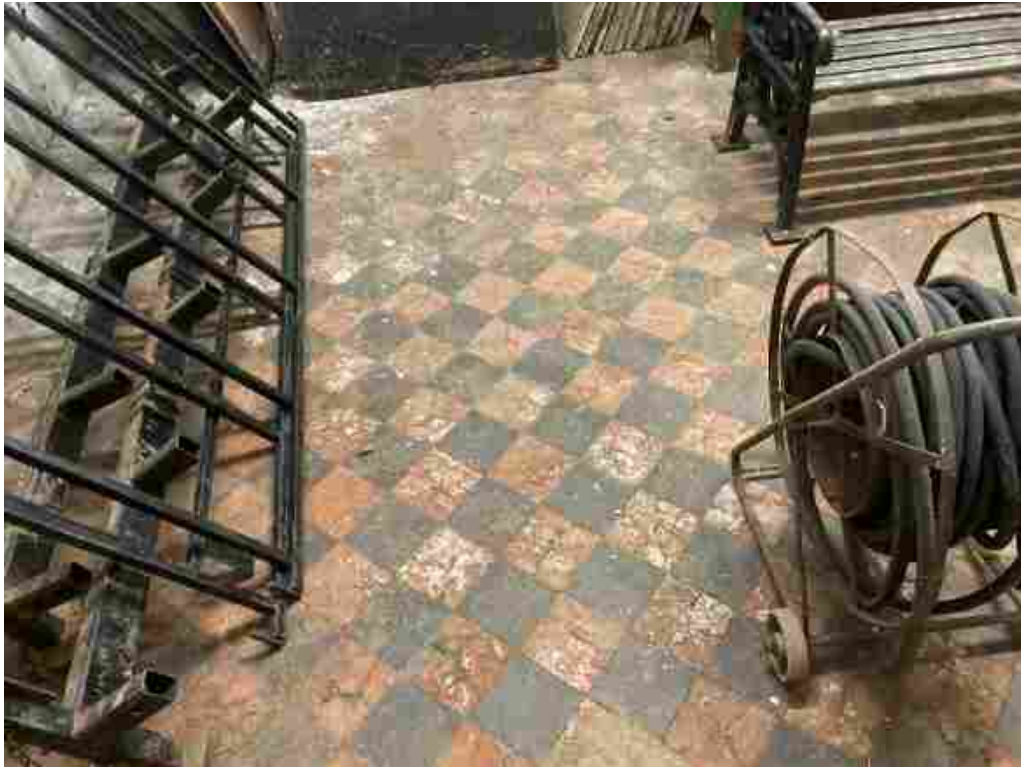
Heavy decay and damage to quarry tiles.
