# Gainsborough Town Council

You are hereby summoned to attend a meeting of **Property and Services Committee** which will be held on **Tuesday 11 April 2023** commencing at **7pm** in the meeting room, **Richmond House, Richmond Park, Morton Terrace, Gainsborough.**

| Agenda no | Agenda item title | Power |
|---|--|--|
| PS23/217 | To <b>note</b> the arborist's report and recommendations and consider any action to be taken resulting from this.<br><b>Paper B</b> | <i>Localism Act 2011, s 1-8.</i> |

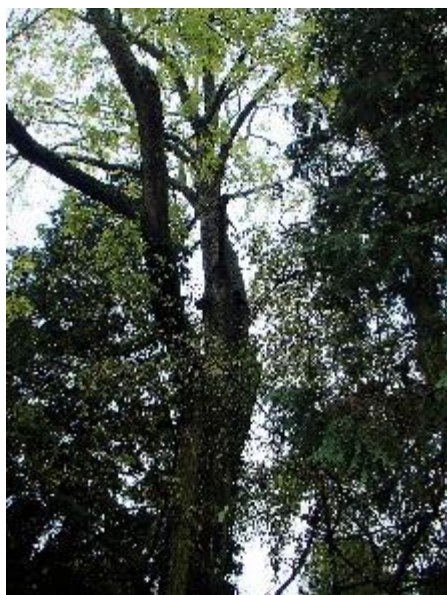
| Reference | Species | Recommendations | Priority |
|---|---|--|---|
| 22, 23 RP | Ash Oak | Recommend Pruning - crown cleaning & check | Low/Medium |

**Photo 1:** Oak T23 Prune & aerial check (same for adjacent Ash 22).

The remaining concerns are crown cleaning or pruning operations. High-level crown cleaning is recommended on the larger trees where deadwood is more significant, in particular Ash T22, Oak T23, Sycamore T50, Beech T65 and Cedar T81. At the same time aerial check surveys can be completed on various high-level junctions and stem and branch cavities.

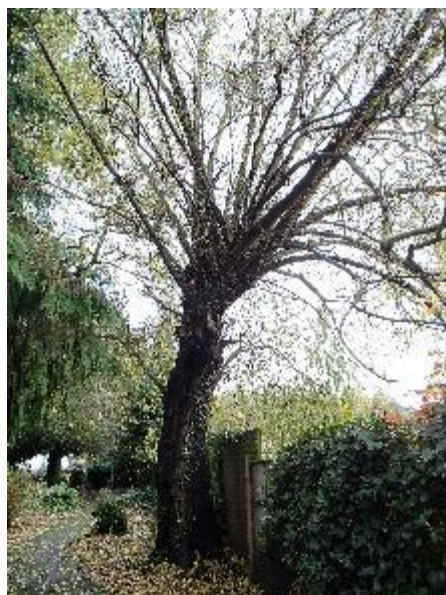
| Reference | Species | Recommendations | Priority |
|---|---|--|---|
| 40 RP | Willow | <b>Recommend Pollard or Fell</b> | Medium |

**Photo 2:** Willow T40 Fell or re-pollard.

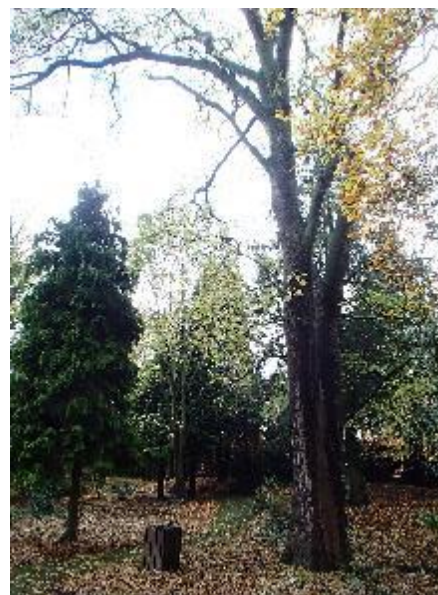
**Photo 3:** Sycamore T50, crown clean and aerial check.

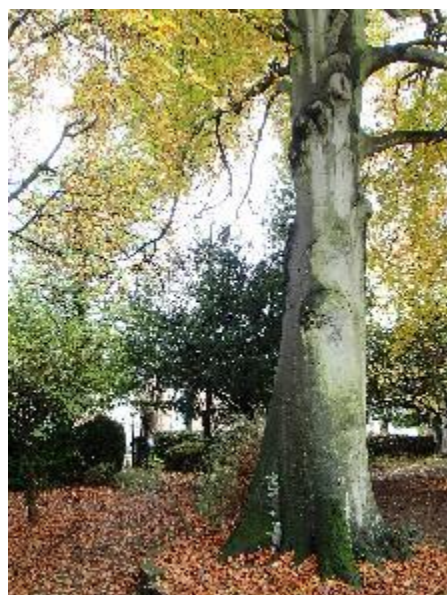
**Photo 4:** Beech T65, crown clean and aerial check.

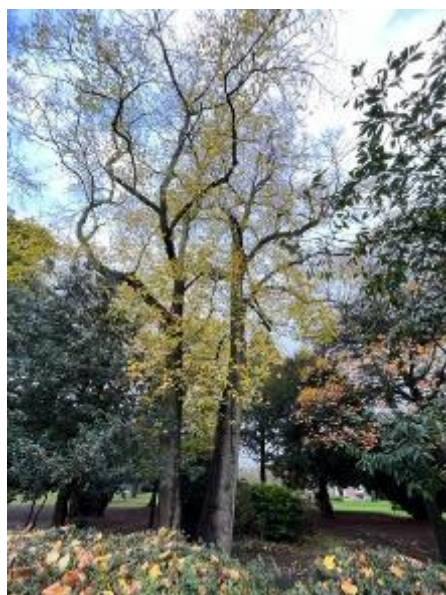
**Photo 5:** Lime T73, crown clean and aerial check.

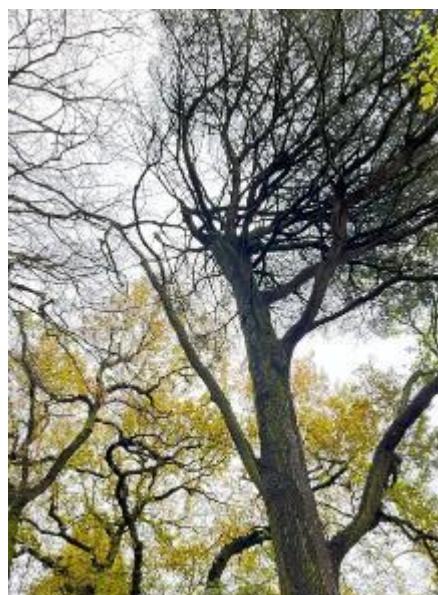
| Reference | Species | Recommendations | Priority |
|---|---|--|---|
| 81 RP | Cedar | Recommend Pruning - crown cleaning & check | Low/Medium |

**Photo 6:** Cedar T81, deadwood, rebalance and aerial check.

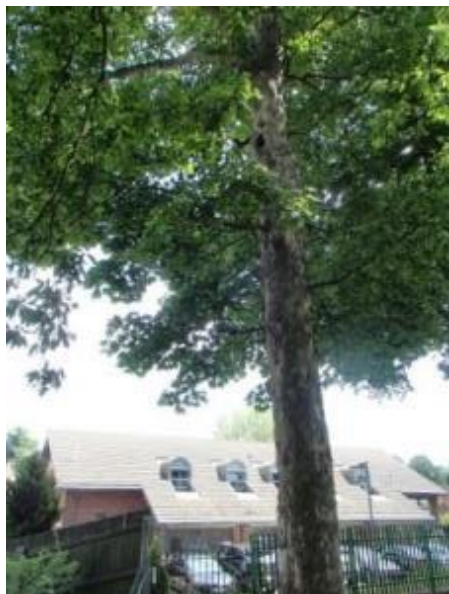
| Reference | Species | Recommendations | Priority |
|---|---|--|---|
| 215 NWC | Sycamore | Recommend Pruning | Low |

**Photo 7:** Sycamore T215, pruning recommended and aerial check.

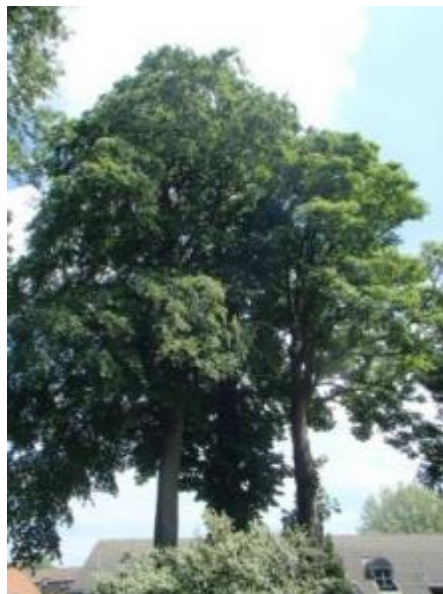
Individually, two trees have recommended work in the low and medium risk category, *these items being identified in the 2020 Report but not yet attended to*. The pruning of Sycamore T215 is easily resolved, while Chestnut T217 has again been strongly recommended for either re-pollarding or full felling for two reasons - to eliminate any possible risk, however small, due to its location, and to promote the adjacent better-quality trees for management reasons. The risk associated with leaning Cypress T224 has been re-considered and is slightly downgraded as a result, to reflect the fact the lean has seemingly stabilised.

| Reference | Species | Recommendations | Priority |
|---|---|--|---|
| 217 NWC | Horse Chestnut | <b>Recommend Fell, or Pollard if desired</b> | Medium |

**Photo 8:** Horse Chestnut T217 Recommend fell or pollard.

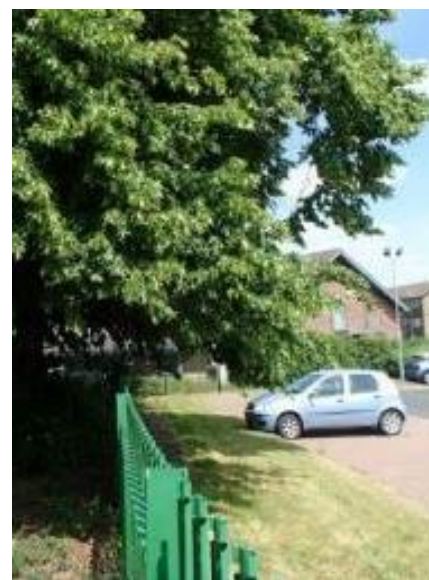
**Photo 9:** Lime T222, minor overhang to control.

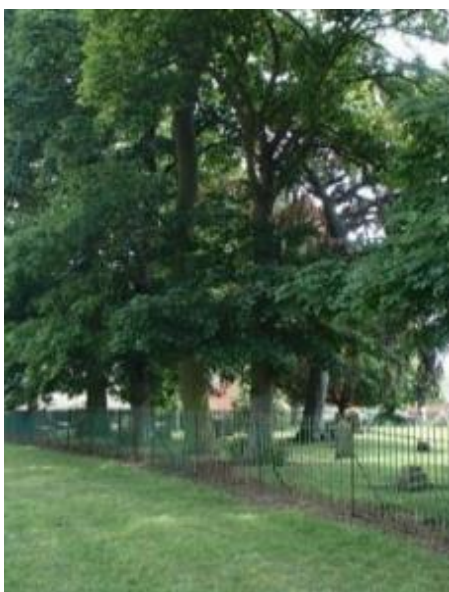
**Photo 10:** North Boundary trees, minor deadwood throughout.

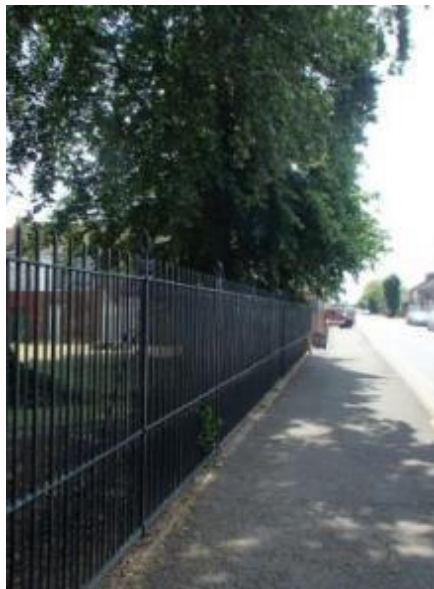
**Photo 11:** West boundary, T230 to T232, overhang to control.

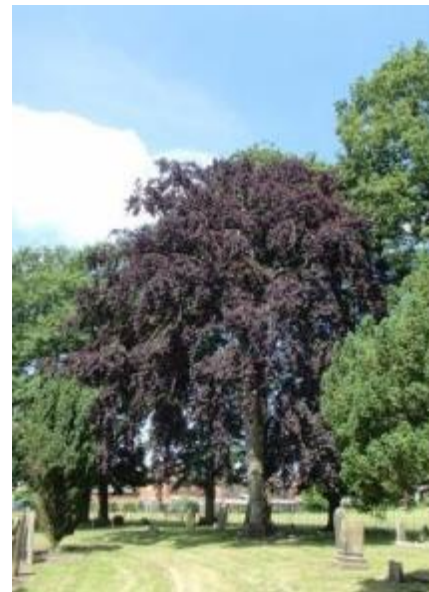
**Photo 12:** Beech T237, initial decline, ongoing monitoring.

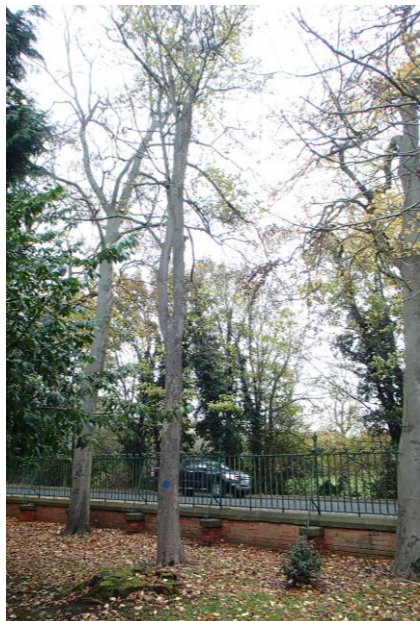
| Reference | Species | Recommendations | Priority |
|---|---|--|---|
| 284 GC North | Sycamore | <b>Recommend Fell, or Pollard if desired</b> | Medium |

**Photo 13:** Sycamore 284, recommend Fell

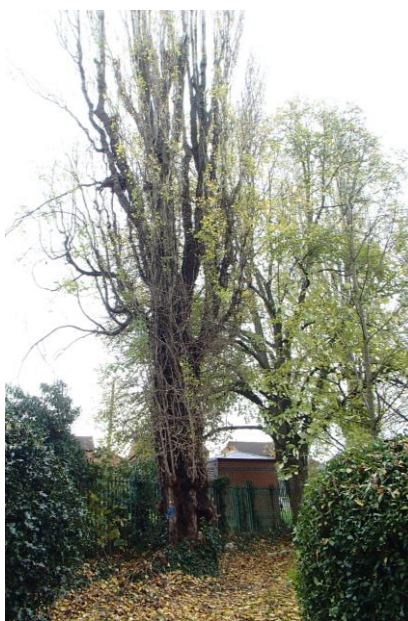
| Reference | Species | Recommendations | Priority |
|---|---|--|---|
| 303 GC North | Poplar | <b>Recommend Fell or Pollard if desired</b> | Medium |

**Photo 14:** Poplar 303, recommend Fell or re-pollard

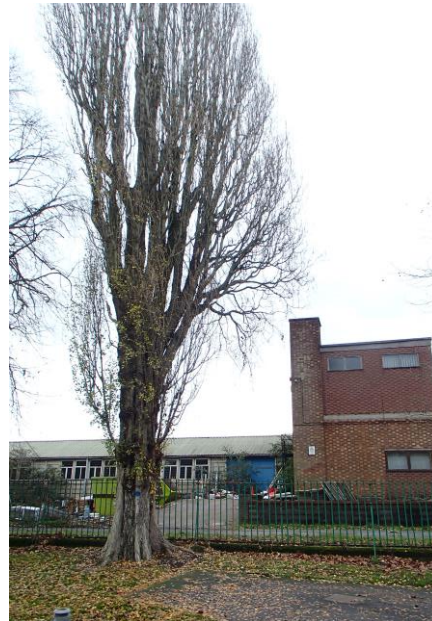
| Reference | Species | Recommendations | Priority |
|---|---|--|---|
| 316 GC North | Poplar | <b>Recommend Fell</b> | Medium/High |

**Photo 15:** Poplar 316, strongly recommend fell and replace.

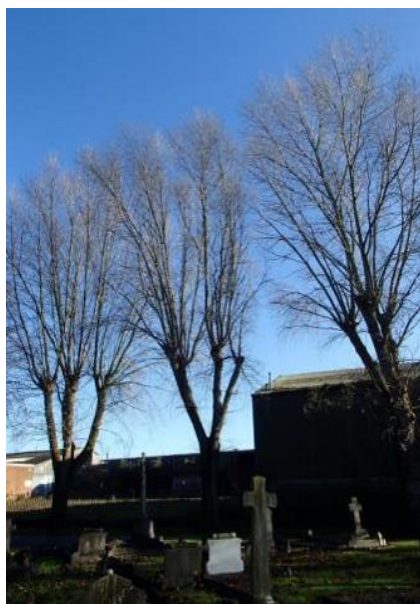
As a group, it is suggested that boundary Poplars are the most problematical species-block and this will only intensify the risk as their age and size increases. Pollarding has been historically completed on some of these and does admittedly instantly reduce any hazard, at the risk of more intensive and regular work having to be done in the future.

**Photo 16:** Typical Poplar form, south-eastern boundary. Management scheme needed.

In the short to medium term, preparation of a 'Poplar Replacement Strategy' is strongly suggested so that a balanced and managed replacement scheme can be agreed. Such a strategy may need advancing if the housing development identified for the adjoining site to the south east comes closer to reality.

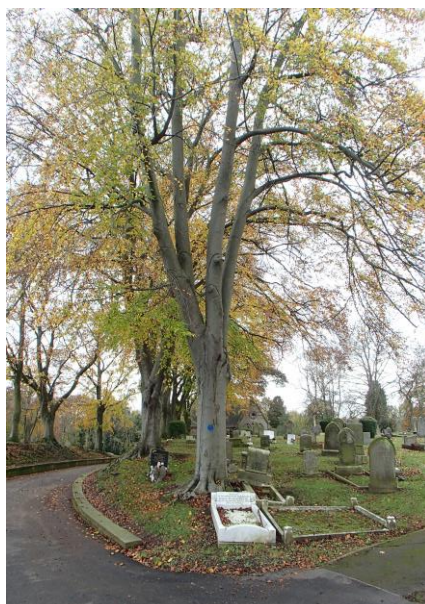
Likewise, many of the Cemetery Beech are becoming very mature and the virulent fungal decay agent *Meripilus giganteus* is known to be present. A number of large mature trees have already been removed but this should not preclude replacement Beech planting, as young, strongly growing Beech do not readily succumb to this fungus. A Beech (renewal) Strategy is particularly suggested in relation to the twin line of trees along the central access drive, numbered 343 to 354.

| Reference | Species | Recommendations | Priority |
|---|---|--|---|
| 347 GC North | Beech | <b>Recommend Fell</b> | Medium |

**Photo 17:** Beech 347, decayed, with fungus, recommend fell (pollard not an option).

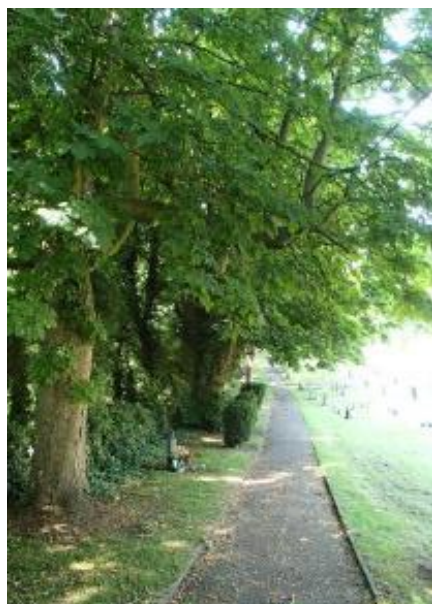
| Reference | Species | Recommendations | Priority |
|---|---|--|---|
| 396 to 402 GC | Various | Recommend crown lifting | Low |

**Photo 18:** Group 396 – 402, crown lifting above path. Photo from summer.

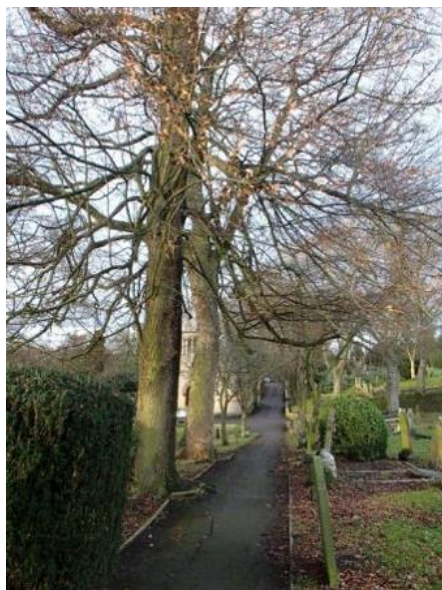
**Photo 19:** Group 415 to 421. Suggest crown lifting over path.

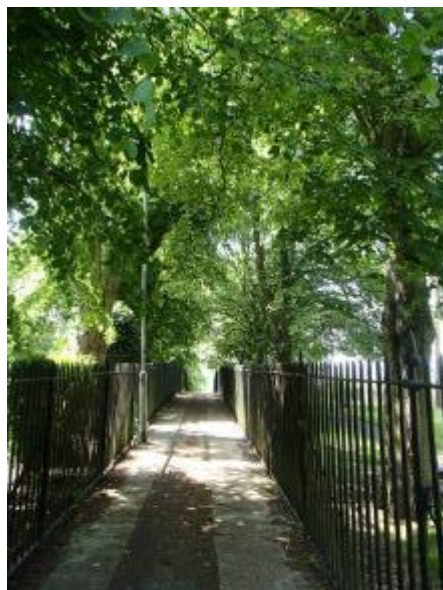
**Photo 20:** Groups 330 – 335 and 471 – 475. Suggest crown lifting over path. Photo from summer.

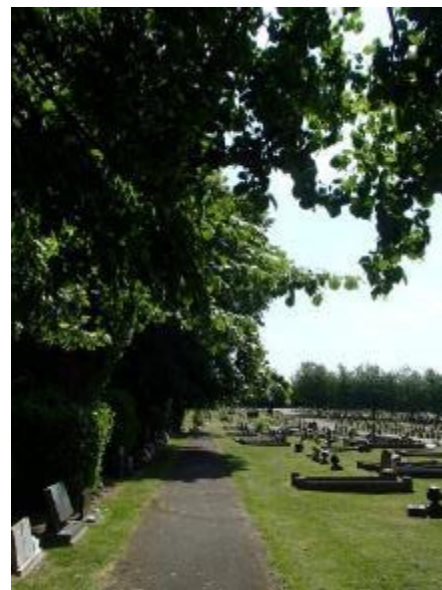
| Reference | Species | Recommendations | Priority |
|---|---|--|---|
| 447 GC South | Lime | Recommend crown cleaning and prune | Low/Medium |

**Photo 21:** Eastern boundary group 446 – 454, including Lime 447 to be crown cleaned.

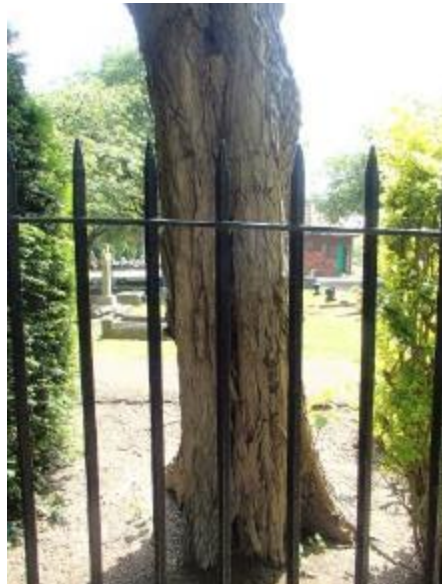
| Reference | Species | Recommendations | Priority |
|---|---|--|---|
| 474 GC South | Poplar | <b>Recommend Fell</b> | Medium/High |

**Photo 22:** Poplar 474, cavity. Strongly Recommend fell.

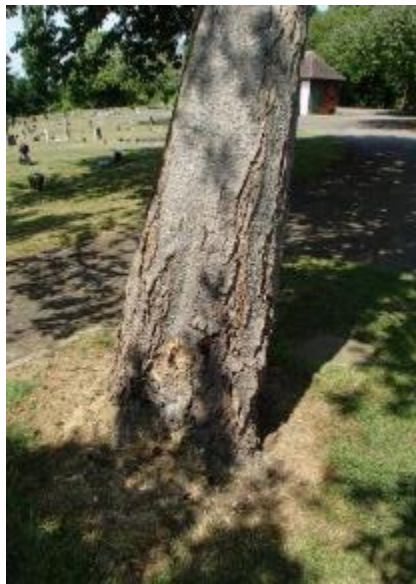
**Photo 23:** Base of Alder 458, in decline, monitoring needed. Photo from summer.

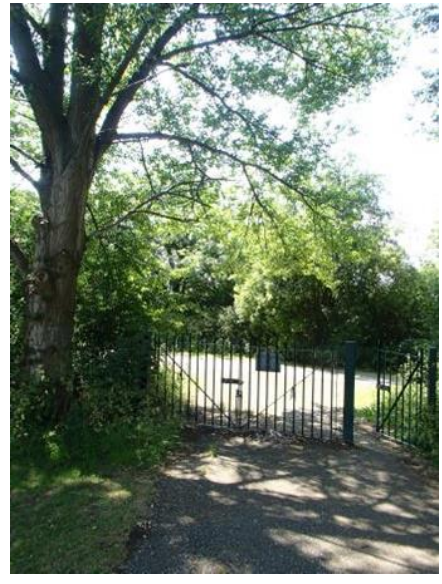
| Reference | Species | Recommendations | Priority |
|---|---|--|---|
| 485, 489, 492 | Hybrid Poplars | Recommend Pruning, crown lift and reduction | Low |

**Photo 24:** Typical Silver Poplar west boundary, 485 – 492 group.

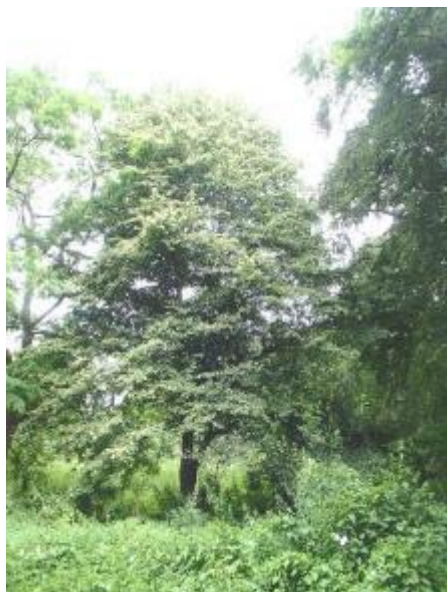
**Photo 25:** Lime, T550. Crown lift required when work proceeds

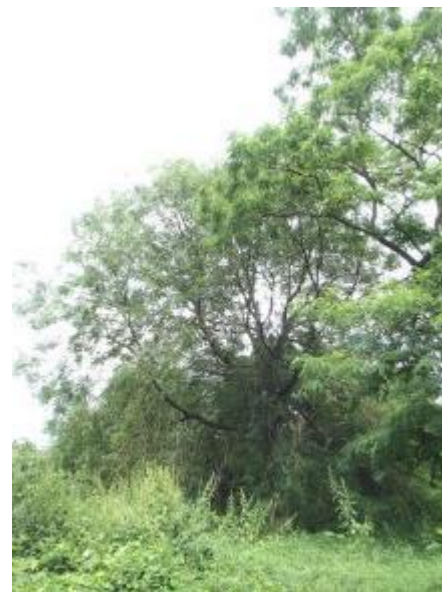
**Photo 27:** Ash T552. Crown lift required when work proceeds.

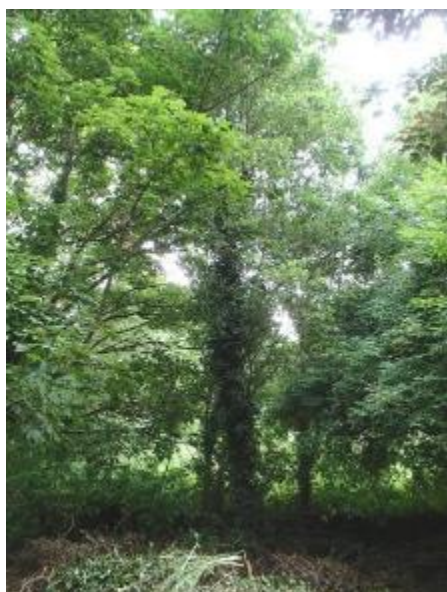
**Photo 28:** Sycamore T553 and Syc/Ash group, suggest thorough thinning, crown lift and Ivy cut.

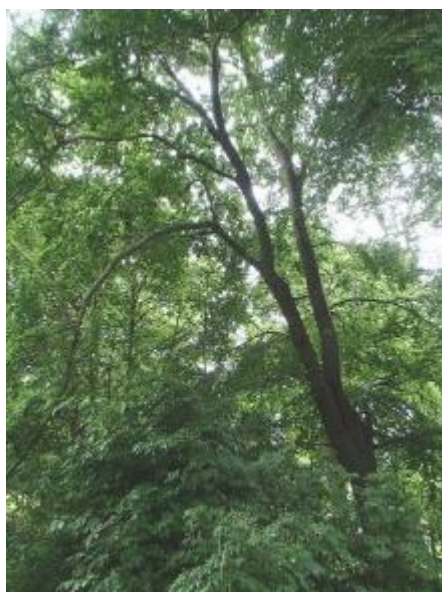
**Photo 29:** Beech (383?) in Cemetery, significant deadwood. Seen from within extension site.

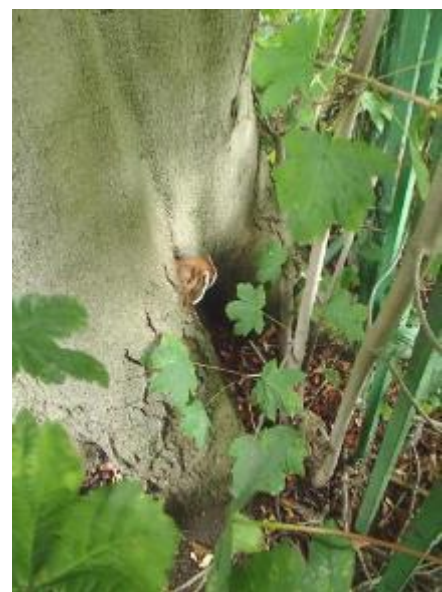
**Photo 30:** Beech 383, with *Ganoderma* bracket, leaning north towards extension site.
