# Gainsborough Town Council

## PROPERTY AND SERVICES COMMITTEE AGENDA

**PS26/024 General Cemetery Chapel Condition Survey (Paper H)**

**Love Lane Alotments  
Gainsborough**

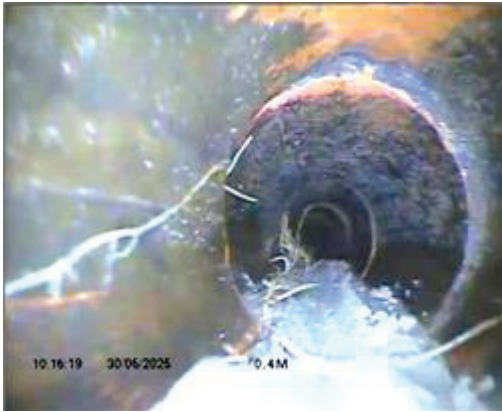
| Pos | Video Ref | Code | Description | Image |
|---|---|---|---|---|
| 00.40m | 0:00:26 | R | Roots - Severity 3 | Image Provided - Ref: 0_2<br> |

- Significant silt and root ingress identified.
- Contractor recommendation: replace the entire section.
- Quotation: installation of approx. 43m of new land drain from inspection chamber to dyke (cutting in front of shed at Plot 31b) at a cost of **£3,200 + VAT**.

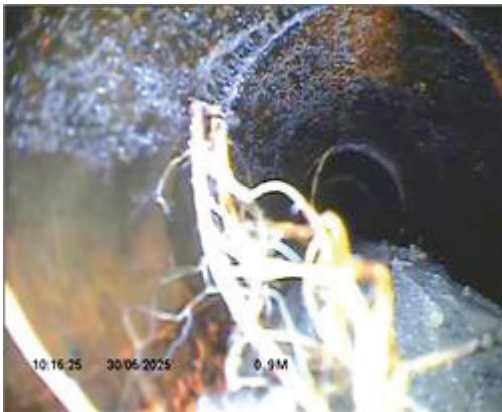
| Pos | Video Ref | Code | Description | Image |
|---|---|---|---|---|
| 00.90m | 0:00:33 | R | Roots - Severity 3 | Image Provided - Ref: 0_3<br> |

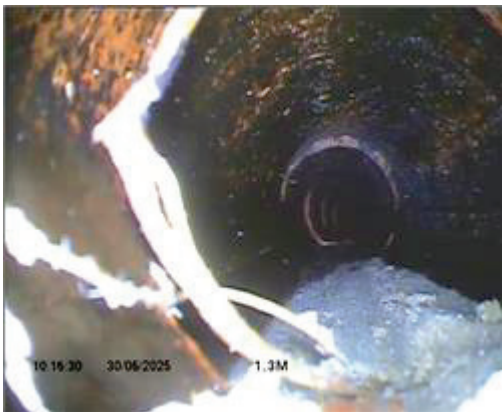
| Pos | Video Ref | Code | Description | Image |
|---|---|---|---|---|
| 01.30m | 0:00:37 | R | Roots - Severity 3 | Image Provided - Ref: 0_4<br> |

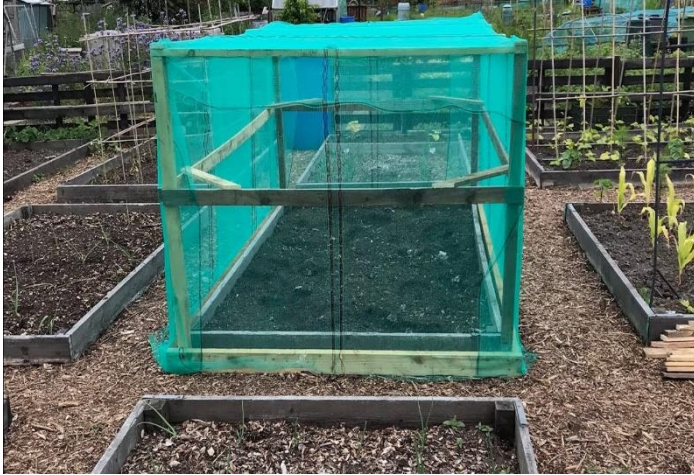
### **Example of a walk-in brassica / fruit cage**

- The structure should be moveable – not concreted into the ground.
- The structure should be no more than 6ft in height, 6ft in length, 4ft in width, with a flat roof, to allow for tenants to walk into the structure (like a poly tunnel).
- The frame, if constructed with wood, should be no more than 2x2 inch wooden battens  
Netting to be used for coverage.
